**Service Bulletin**

**SUBJECT:** Service Update for Inventory and Customer Vehicles

220 Amp Generator Fuse Block Corrosion

MODELS: 2015 Chevrolet Silverado 2500 HD

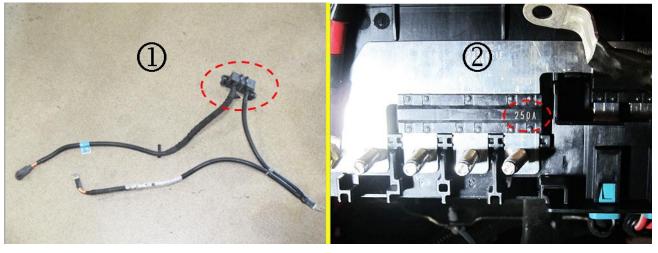
40094453

**Note:** With the new parts design, the 250 Amp fuse which was previously located on the cables (1) has now been re-located in the fuse battery distribution block (2).

This bulletin provides a service procedure to relocate the separate 250 Amp fuse into the prefuse assembly on top of the vehicle battery on **certain** 2015 model year Chevrolet Silverado 2500 HD and GMC Sierra 2500 HD vehicles equipped with a 220 Amp Generator (RPO KW5). These vehicles may, due to corrosion at the ends of the fuse, experience a resistance build-up that does not allow current to flow through the fuse, resulting in the generator not being able to charge the vehicle battery. The battery symbol may appear on the IP and a message in the driver information center will show "Service Battery Charging System." As the battery loses charge, the vehicle may stall or not be able to start when the battery goes below 11.3 Volts. Depending on the state of charge of the battery when this occurs, the vehicle may have between 50-85 minutes before any potential stall condition.
