Program Bulletin

CUSTOMER SATISFACTION PROGRAM

SUBJECT: Passenger Airbag Status Indicator Illumination

MODELS: 2014 Cadillac CTS (VIN A)

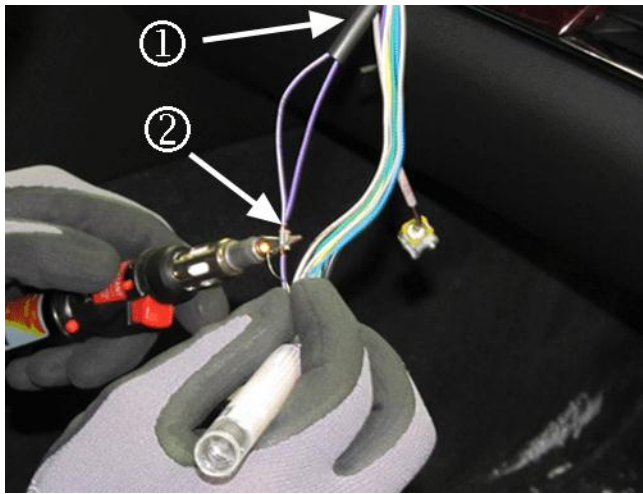
3902217

Caution: Keep the heat shrink tube (1) above the splice when soldering the splice (2) to ensure that the heat shrink is not prematurely shrunk and closed down over the wire or splice area due to the heat from the soldering iron.

11. Solder the crimp and splice clip using the Ultratorch, part number J-38125-5, or another butane fueled soldering iron.
