Program Bulletin

CUSTOMER SATISFACTION PROGRAM

SUBJECT: Seat Mounted Side Impact Airbag Connector

MODELS: 2014 Chevrolet Silverado 1500
2014 GMC Sierra 1500

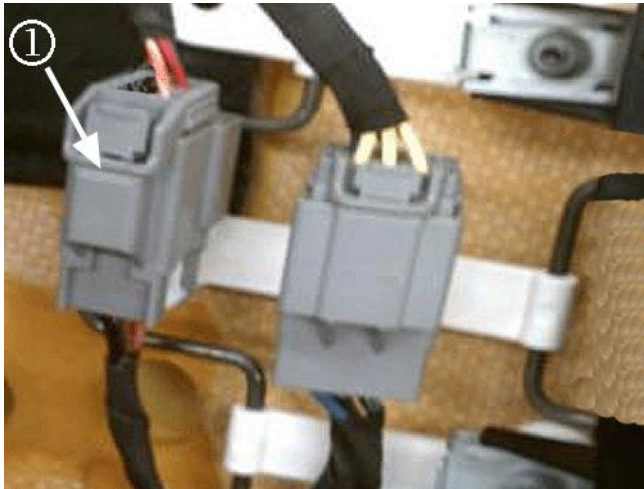
3957349

Note: Perform the procedure in this bulletin on BOTH the front driver and passenger seat. The SIAB connectors are located under the seat cushion, and the technician may find a single SIAB connector or may find a second connector with power seat circuits next to it. On the driver side it is a GREEN connector on the outboard side of the seat; on the passenger side it is a GREY connector on the inboard side of the seat.

1. Starting on the passenger seat, locate the inboard grey SIAB harness connector (1) on the underside of the seat cushion.

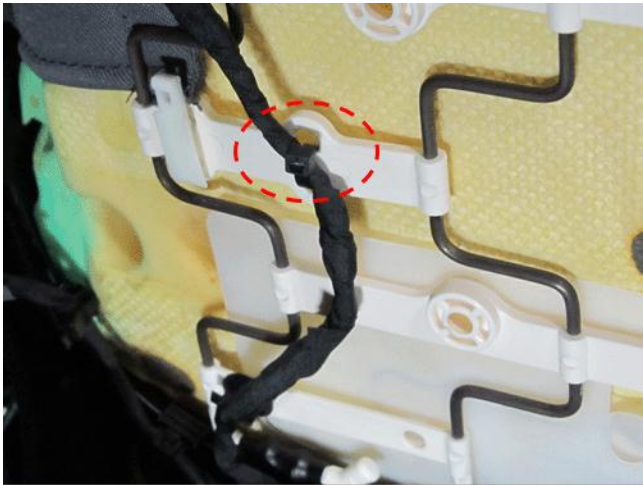
3957379

Note: The graphic above is for illustration purposes only to show the tie strap location. In this repair, the harness would have already had the yellow tape applied in the previous step.

Caution: Avoid routing the harness along sharp metal edges. Ensure that harness is secured with some slack in the harness to allow the harness to flex or move.

13. Using the original mounting hole for the removed connector, secure the harness in position using a nylon tie strap.
