Bulletin No.: 14176A
Date: September 2014

Recall Bulletin

SUBJECT: Improperly Crimped Accelerator Pedal Position Electrical Terminals

MODELS: 2014 Cadillac ATS

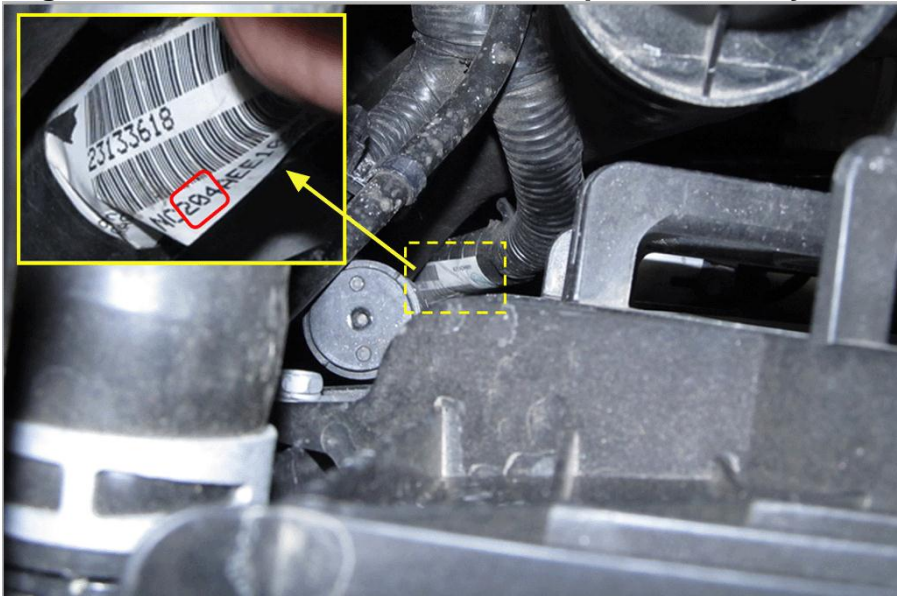
3942442

Tag and Date Code as Viewed from Top on a Four Cylinder Vehicle

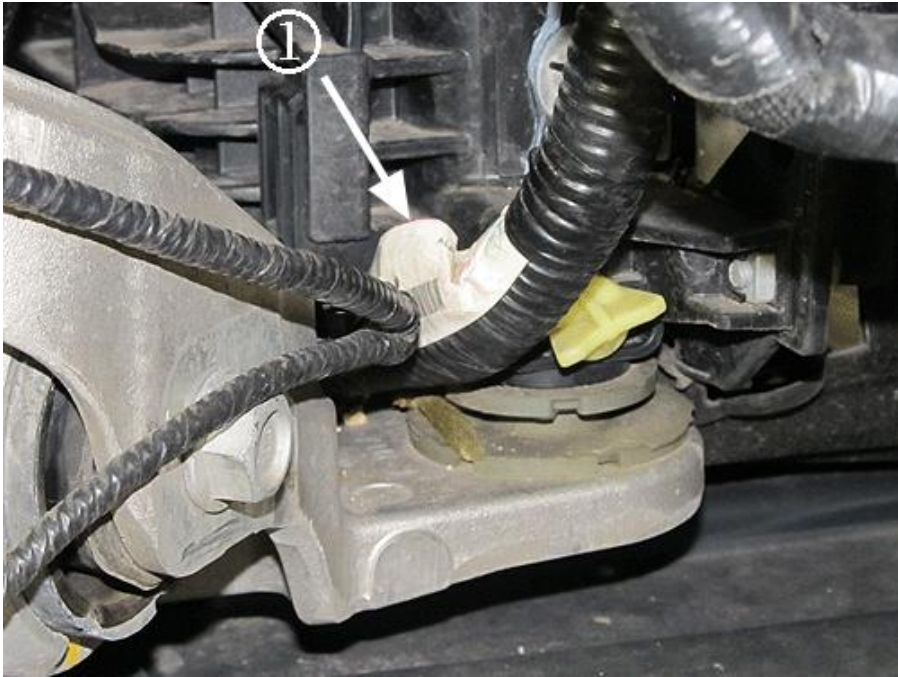
3942440

Tag (1) as Viewed from Bottom on a Six Cylinder Vehicle

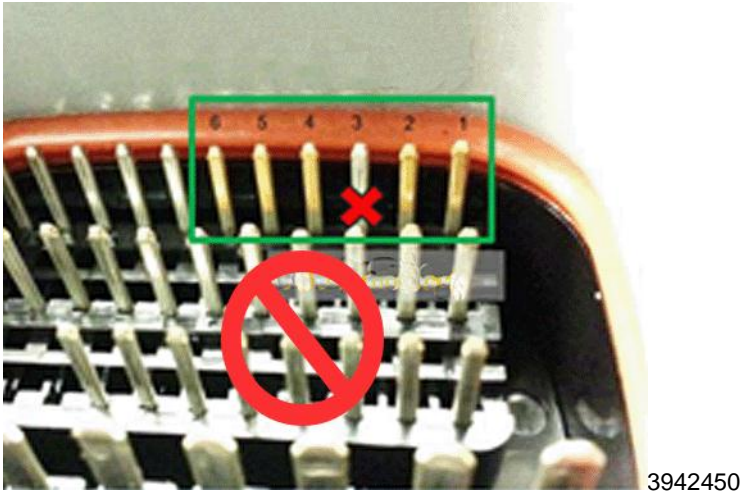
Caution: The Accelerator Pedal Position (APP) sensor circuits are cavities 1 through 6 within the X150 connector. All six terminals for APP must be gold plated.

7. Disconnect the connector and inspect the engine-side (male) terminals, 1 through 6 (1). As shown in the graphic above, the six terminals are gold and the surrounding terminals are tin.
 - If the Julian date code is **outside** the 182 – 187 range AND all six terminals are gold plated, no further action is required. Proceed to *Reassembly Procedure* below.

- If the Julian date code is **outside** the 182 – 187 range AND any tin plated terminals are found (like example shown in third terminal above), proceed to *Terminated Lead Replacement Procedure* below.
- If the Julian date code is **within** the 182 – 187 range AND all six terminals are gold plated, proceed to *Solder Terminal Crimps Repair Procedure* below.
- If the Julian date code is **within** the 182 – 187 range AND any tin plated terminals are found, solder the gold terminals and replace any tin terminals with a gold terminated lead. Follow first the *Terminated Lead* procedure, then the *Solder Terminal Crip* procedure below.
