Recall Bulletin

PRODUCT EMISSION RECALL

SUBJECT: Improperly Crimped Accelerator Pedal Position Electrical Terminals

MODELS: 2014 Cadillac ATS

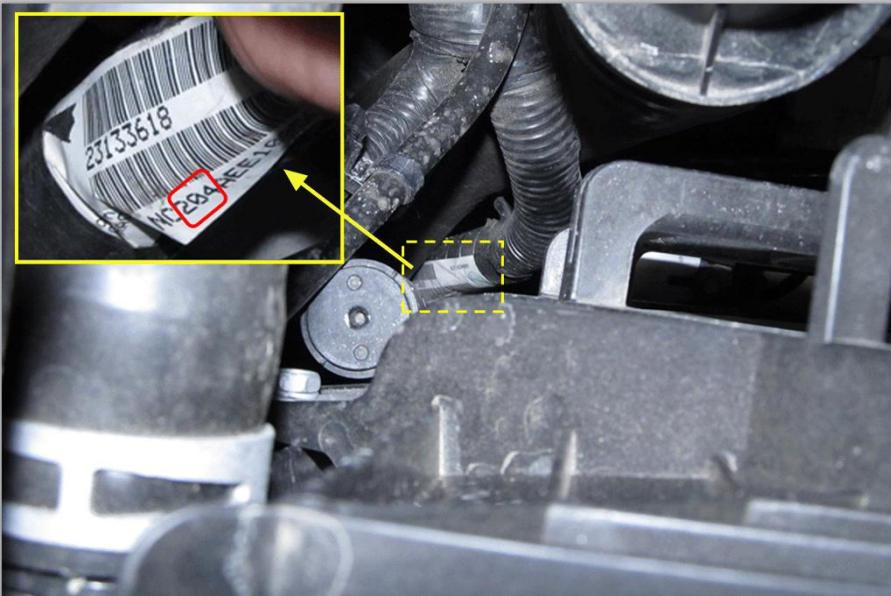
3942442

Note: The tag is located near the bottom right side of the radiator, reposition the forward engine harness to inspect the tag as shown in the photos below. On four cylinder engine vehicles, the tag can be seen from the top with the hood open. For six cylinder engine vehicles, you will not be able to visually access the label/tag (1) from the top engine compartment. Tags on six cylinder engine vehicles will have to be inspected after vehicle is raised on a hoist and the wheelhouse liner is removed.

Tag and Date Code as Viewed from Top on a Four Cylinder Vehicle

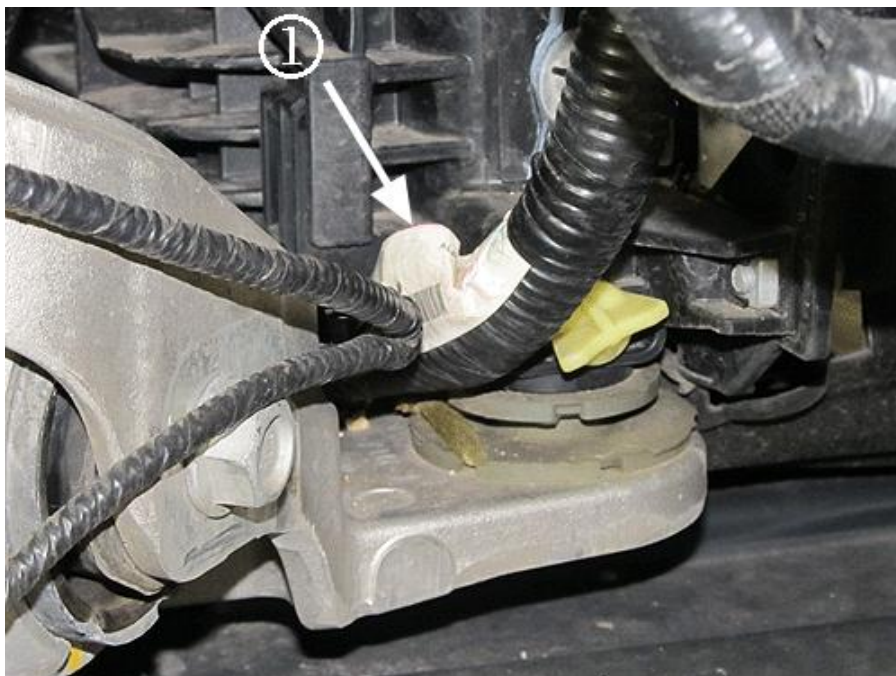
3942440

Tag (1) as Viewed from Bottom on a Six Cylinder Vehicle

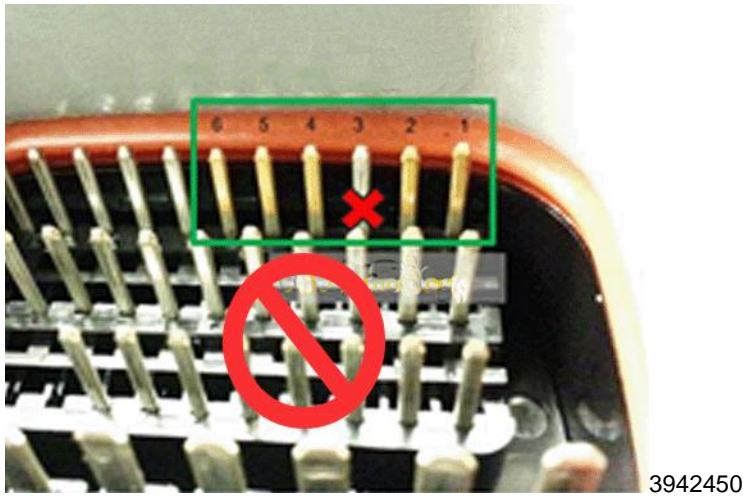
3942450

Caution: The Accelerator Pedal Position (APP) sensor circuits are cavities 1 through 6 within the X150 connector. All six terminals for APP must be gold plated.

7. Disconnect the connector and inspect the engine-side (male) terminals, 1 through 6 (1). As shown in the graphic above, the six terminals are gold and the surrounding terminals are tin.
 - If the Julian date code is **outside** the 182 – 187 range AND all six terminals are gold plated, no further action is required. Proceed to *Reassembly Procedure* below.

- If the Julian date code is **outside** the 182 – 187 range AND any tin plated terminals are found (like example shown in third terminal above), proceed to *Terminated Lead Replacement Procedure* below.
- If the Julian date code is **within** the 182 – 187 range AND all six terminals are gold plated, proceed to *Solder Terminal Crimps Repair Procedure* below.
- If the Julian date code is **within** the 182 – 187 range AND any tin plated terminals are found, solder the gold terminals and replace any tin terminals with a gold terminated lead. Follow first the *Terminated Lead* procedure, then the *Solder Terminal Crip* procedure below.

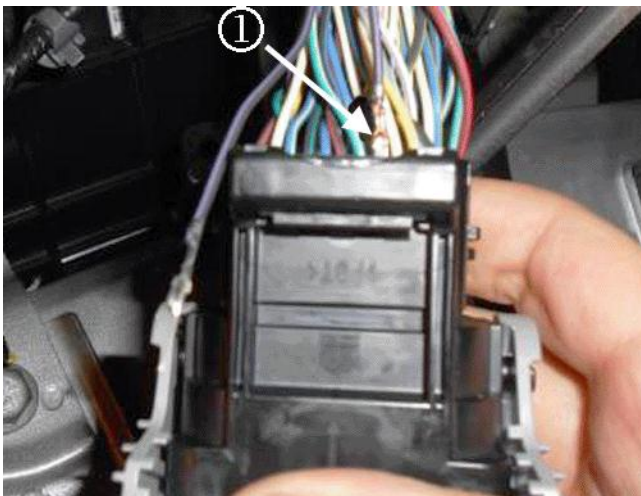
3942455

3. Using a pick (J-38125-11A), or equivalent tool, carefully back out the incorrect tin plated terminal (1) from the connector housing.

4. Place the replacement gold terminated lead (1) into the connector cavity where the incorrect terminal was removed. Ensure that the terminal is fully inserted into the connector, until it clicks using the push-click-pull method.
