# Recall Bulletin

## PRODUCT SAFETY RECALL

**SUBJECT:** Fuse Block Retention

**MODELS:** 2015 Chevrolet Silverado HD  
2015 GMC Sierra HD  
Equipped With 220 Amp Generator (KW5)

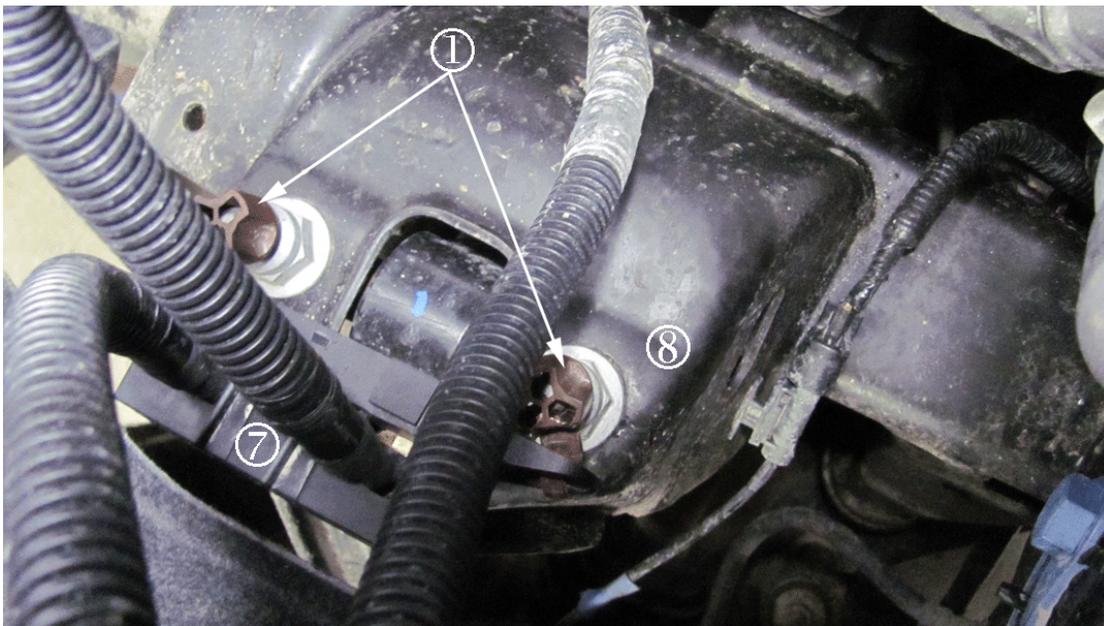
1. Open the hood and locate the fuse block housing assembly. The fuse block housing assembly (7) is located on the right (passenger) side shock tower (8) in the engine compartment.
2. Determine if a fuse block housing assembly rework has been performed.

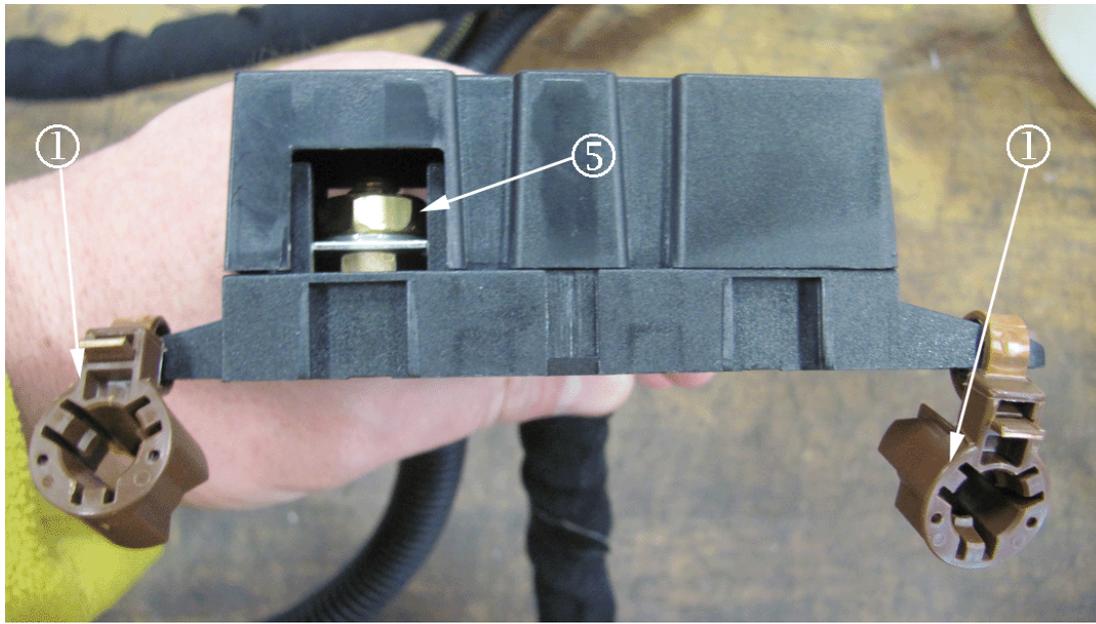
3709060

- A fuse block housing assembly that has NOT been reworked will have two brown clips (1) that secure the fuse block housing assembly to the shock tower studs. The fuse block housing cover will also NOT have a black polyolefin side window shield (5) or a black polyolefin bottom shield that is secured to the fuse block housing assembly with two black tie straps. **If a fuse block housing assembly rework has NOT been performed, perform the rework procedure in this bulletin. Proceed to step 3.**

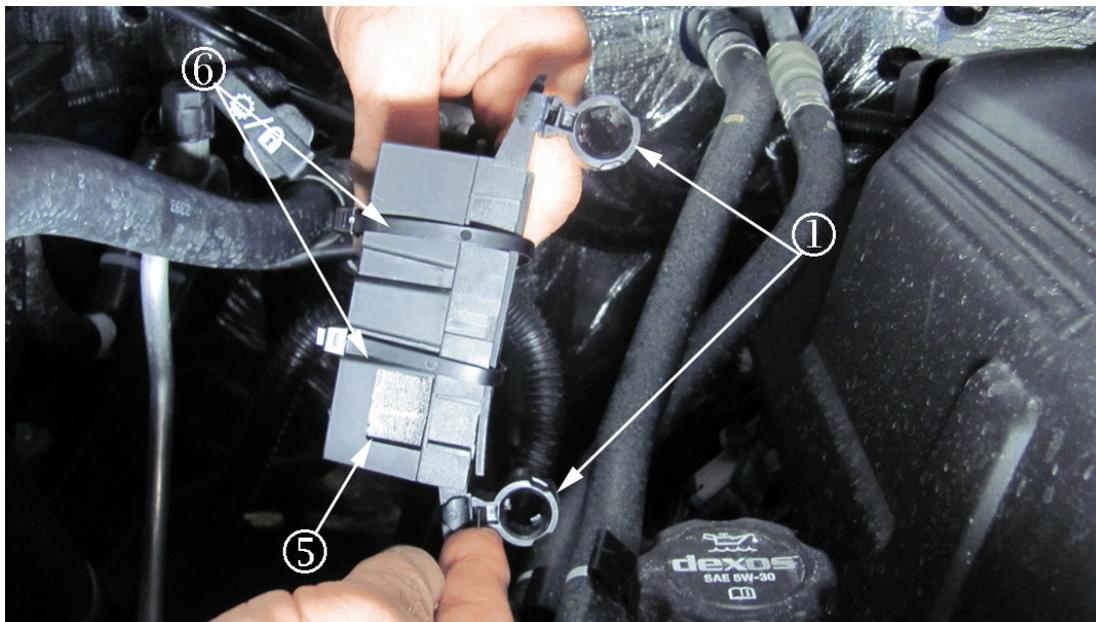
3709065

- A first design reworked fuse block housing assembly will have two black clips (1) that secure the fuse block housing assembly to the shock tower studs. The fuse block housing cover will also have a black polyolefin side window shield (5) and the bottom of the fuse block housing will have black polyolefin bottom shield that is secured to the housing assembly with two black tie straps (6). **If the first design rework has been completed, no further action is required.**
3. Disconnect the negative battery cable. Refer to Battery Negative Cable Disconnection and Connection in SI.

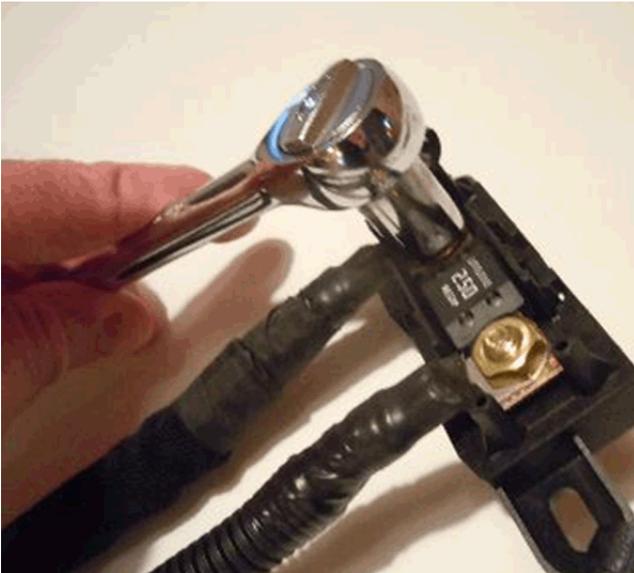
3824970

**Note:** The fastener torque is 15 Nm (11 lb-ft) and does require some effort to loosen the fastener.

5. Using a socket wrench, unscrew the fasteners holding the cables to the fuse bolts.

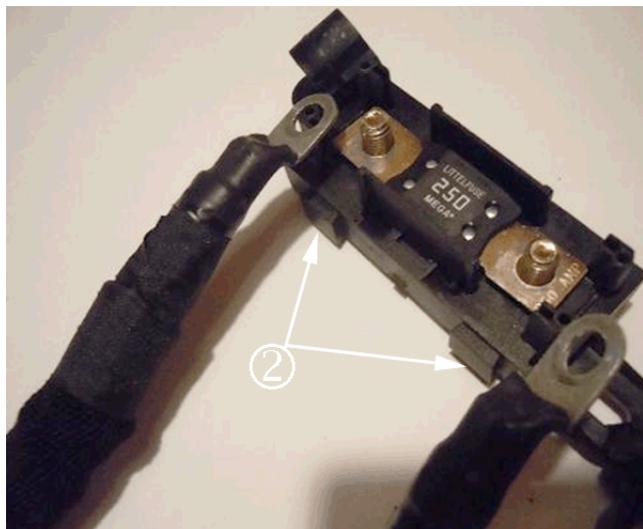
3824911

**Note:** In the current design fuse base, these geometric shaped inserts (2) face the cables as shown in the photograph. When you install the NEW fuse base, these inserts (2) will face AWAY from the cables, allowing the new gaskets to seal best.

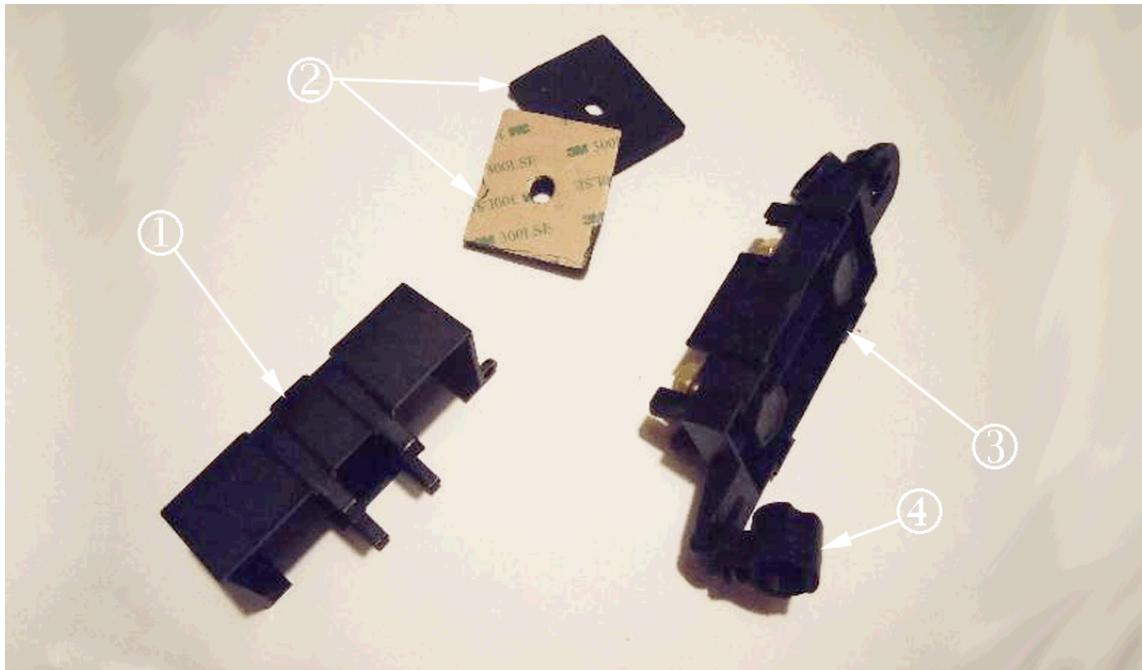
3824953

**Note:** The first design rework kit is no longer available. Use a second design rework kit to update the fuse block assembly. The second design rework kit consists of two foam gaskets with paper backing (2), a new fuse cover with lower mouse hole flashed over (1), and new base with stud bases covered in non-conductive epoxy (includes 250A fuse and nuts) (3). The black mounting clips (4) are attached to the fuse body.

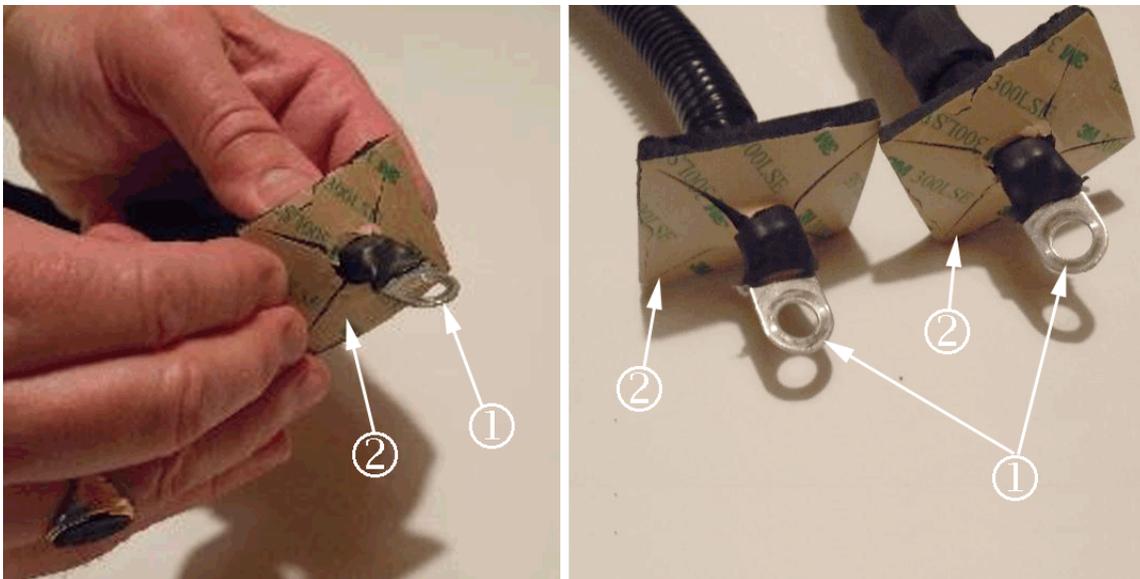
3824944

**Note:** The rectangle foam gaskets are 40mm x 50mm (1.57 in x 2.0 in). The long side of the foam gasket runs parallel with the ring terminal flats as shown in photograph.

7. With the paper backing facing away from the cable, insert the foam gasket (2) through ring terminal (1) as shown in the photograph. Perform this step on both ring terminals.

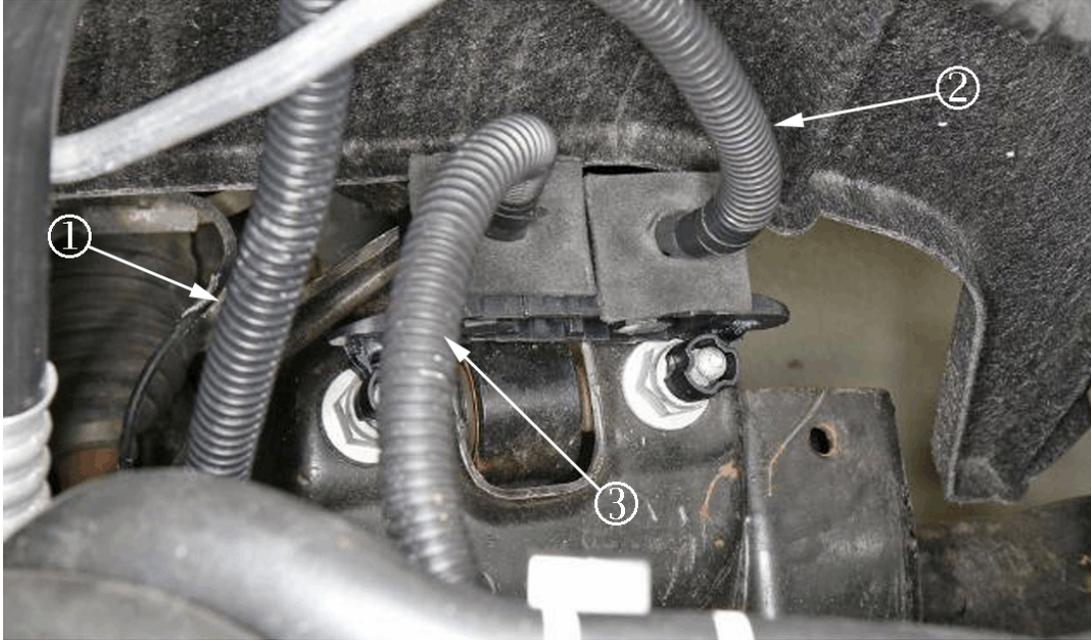
3824963

(1) Starter Cable (2) Fuse Center Cable (3) Generator Cable

14. Install fuse box assembly back onto shock tower.
  - 14.1 Ensure cables are routed as shown in photograph. The starter cable (1) is forward of the two fuse center cables.
  - 14.2 Secure the black clips on the fuse block housing assembly to the shock tower studs.
15. Connect the negative battery cable. Refer to *Battery Negative Cable Disconnection and Connection* in SI.
