# Recall Bulletin

## F/CMVSS NONCOMPLIANCE RECALL

**SUBJECT:** Loss of Driver Door Master Window Function due to Damaged Splice

**MODELS:** 2014 Buick LaCrosse

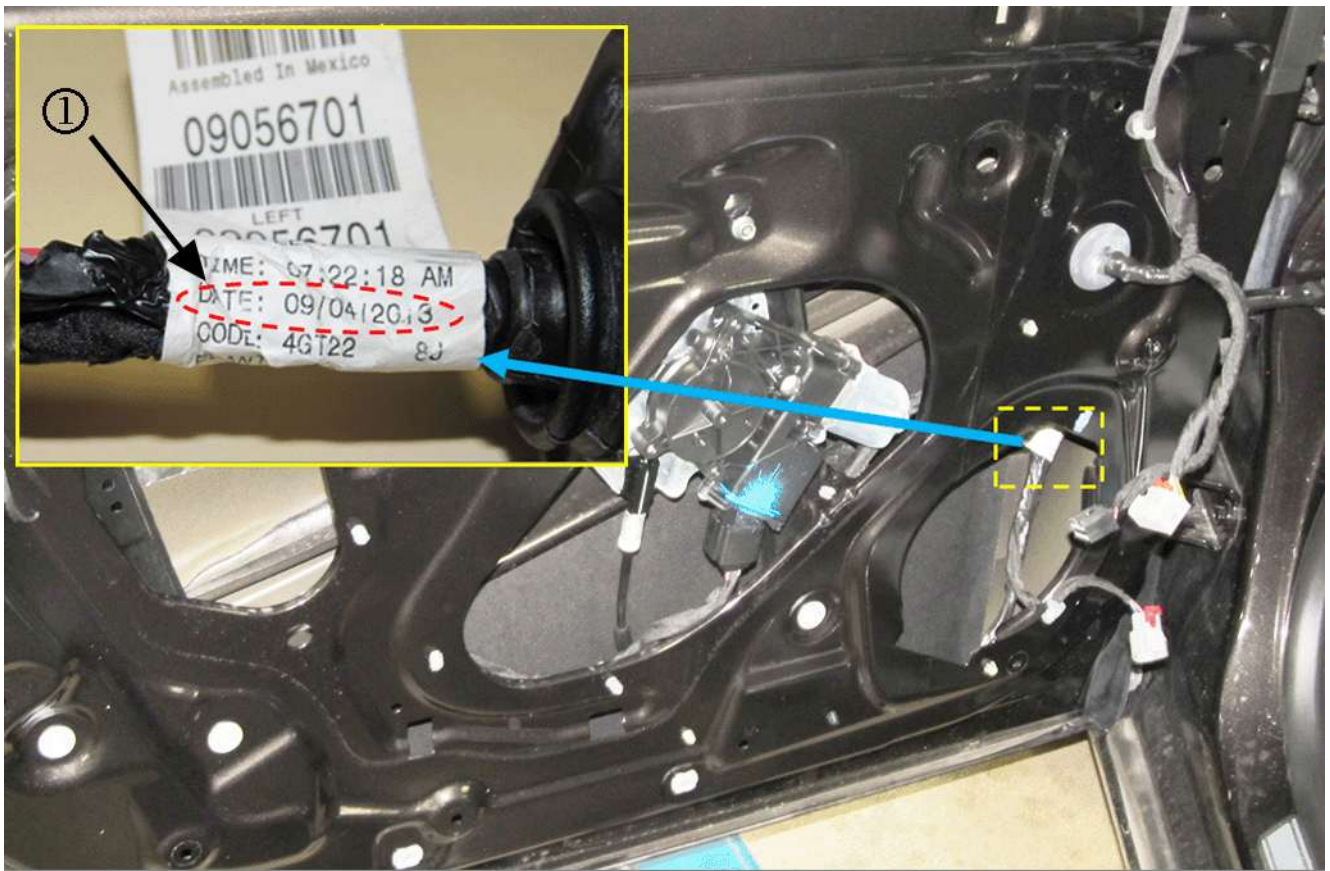
3926783

4. Insert an inspection mirror into the speaker opening and inspect the door wiring harness for a parts tag, which includes a production date (1).
  - If the date on the harness tag is prior to October 2, 2013, the door wiring harness DOES contain the splice failure issue and you should move directly to the *Wiring Repair Service Procedure*.
  - If the date on the harness tag is not prior to October 2, 2013, no further action is required. Reinstall the front speaker and driver door trim panel; Refer to *Radio Front Side Door Speaker Replacement* in SI.

3. Remove the driver door trim panel and the front speaker (1). Refer to *Radio Front Side Door Speaker Replacement* in SI.

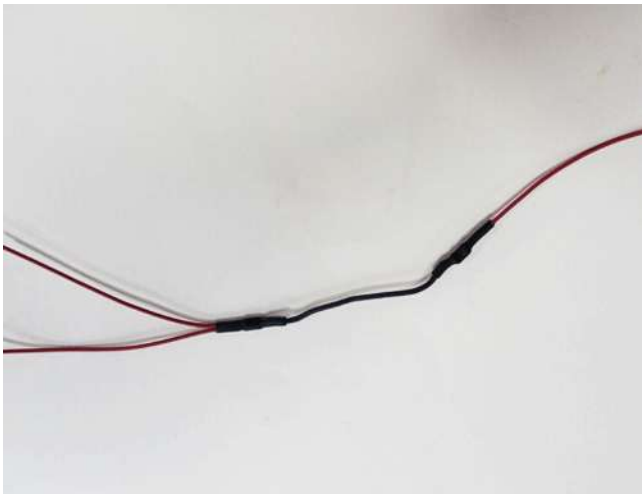
3926787

**Note:** The graphic above is an off-vehicle example of the completed jumper repair.

8. Add an appropriate length jumper wire, obtained locally.
  - 8.1 Strip off approximately 10mm (0.40 in) of insulation from each end of the jumper wire.
  - 8.2 Fold over one end of the jumper wire and position it together with the twisted wires.
