# Recall Bulletin

## F/CMVSS NONCOMPLIANCE RECALL

**SUBJECT:** Passenger Airbag Partial Deployment

**MODELS:** 2015 Cadillac Escalade, Escalade ESV

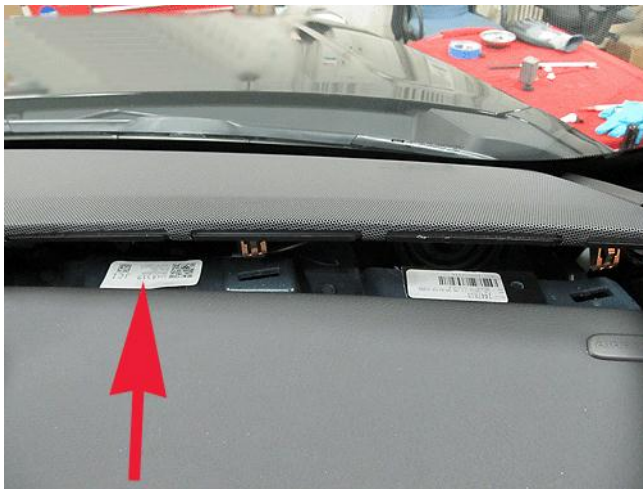
3909687

1. Remove the instrument panel extension. Refer to Instrument Panel Extension Replacement (Cadillac) in SI.

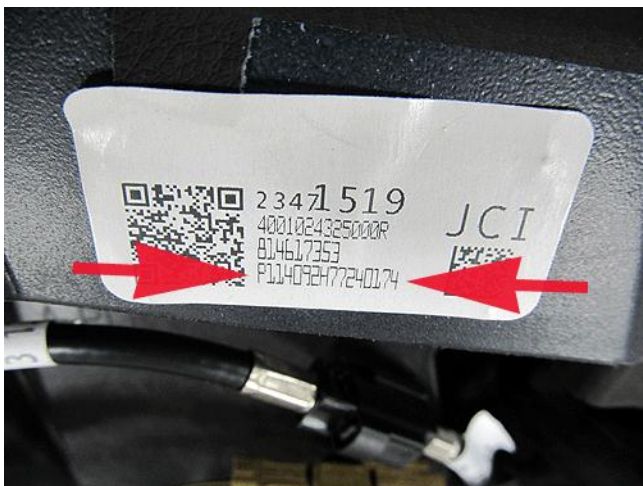
3909688

2. Locate the white paper tag on the instrument panel upper trim panel (there are two labels, it is the label toward the center of the vehicle).
3. Using a digital camera or the camera function on a cell phone, take a clear picture of the label.

4. Compare the last 9 numbers on the label to the Suspect Label Number Table below. The label will appear upside down in the photograph, rotate as required.
  - **If the number does NOT appear on the list**, no further action is required. Reinstall the instrument panel extension.
  - **If the number IS on the list**, return the part to GMCCA and proceed to the Replacement Procedure in this bulletin.
