Recall Bulletin

PRODUCT SAFETY RECALL

SUBJECT: Ignition Key

MODELS: 2010-2014 Chevrolet Camaro

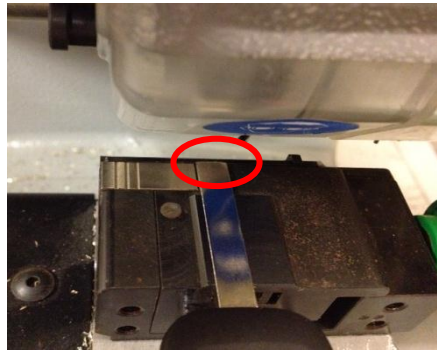
3947698

NOTE: The key blank should fit into the Jaw as shown in the picture. Make sure there is no gap in the area circled in the picture. Remove the guard if necessary.

- a. Select “key search”
- b. Choose “car, model” selection
- c. Enter make, model & hit enter
- d. Select “cut by decode”
- e. Insert the original key into Jaw “C” and change cutter if necessary
