# Service Bulletin

**SUBJECT:** Service Update for Inventory and Customer Vehicles  
Power Liftgate Inoperable  
Expires with Base Warranty

**MODELS:** 2015 Cadillac Escalade, Escalade ESV  
2015 Chevrolet Suburban, Tahoe  
2015 GMC Yukon, Yukon XL  
Equipped with Power Liftgate (TB5/TC2)

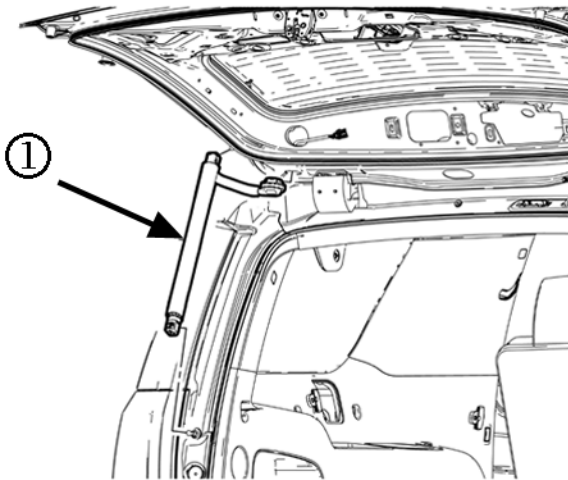
3981552

This bulletin provides a service procedure to replace the liftgate actuator assembly on certain 2015 model year Cadillac Escalade and Escalade ESV, Chevrolet Suburban and Tahoe, and GMC Yukon and Yukon XL vehicles equipped with a power liftgate (TB5/TC2). The power liftgate on these vehicles may have been built with liftgate struts that can lock up and cease to move. If the liftgate strut locks up, the customer may not be able to open or close the liftgate either electronically or manually.

5. Remove the liftgate power assist actuator assembly (1) from the vehicle.
6. Install the new liftgate power assist actuator assembly. Ensure the retainer/clip is fully seated when the actuator rod is installed.
7. Reconnect the pass through grommet and the electrical connector.
8. Reinstall the liftgate upper trim finish panel. Refer to *Liftgate Upper Trim Finish Panel Replacement* in SI.
