PRODUCT SAFETY RECALL

SUBJECT: Driver Front Airbag Inflator Failure

MODELS: 2013-2014 Chevrolet Cruze

GM Recall #14305

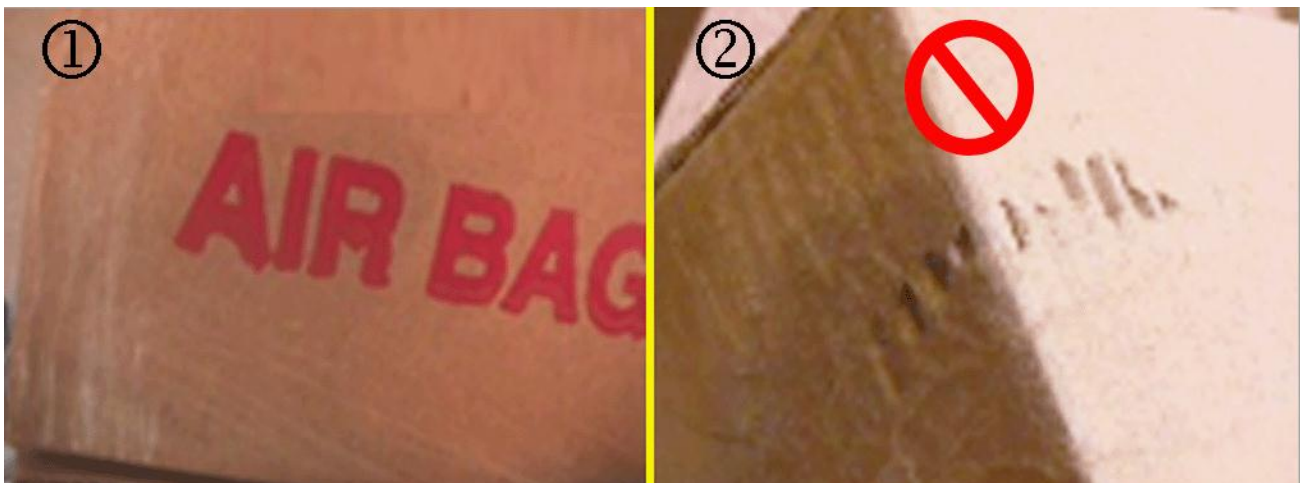
- **Abrasions:** Abrasions result from sliding the package against a rough surface (e.g. concrete floors). Major abrasions (2) are NOT acceptable. Note the flutes are visible.

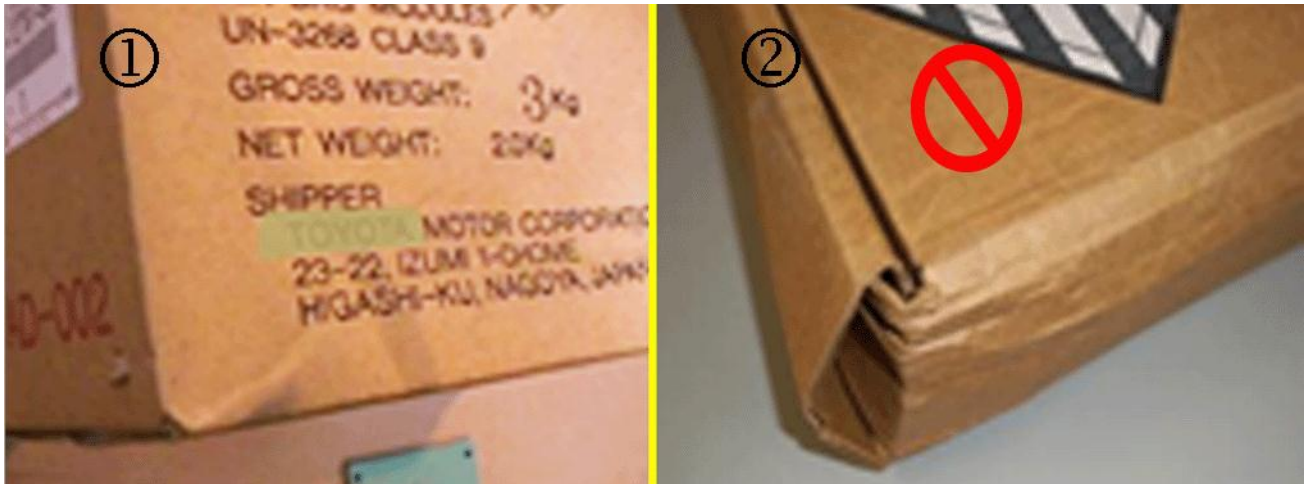
3961563

- **Compressions:** Compressions result from superimposed weights (e.g. stacked too high) or from dropping the packages. Small dimples (1) are acceptable.

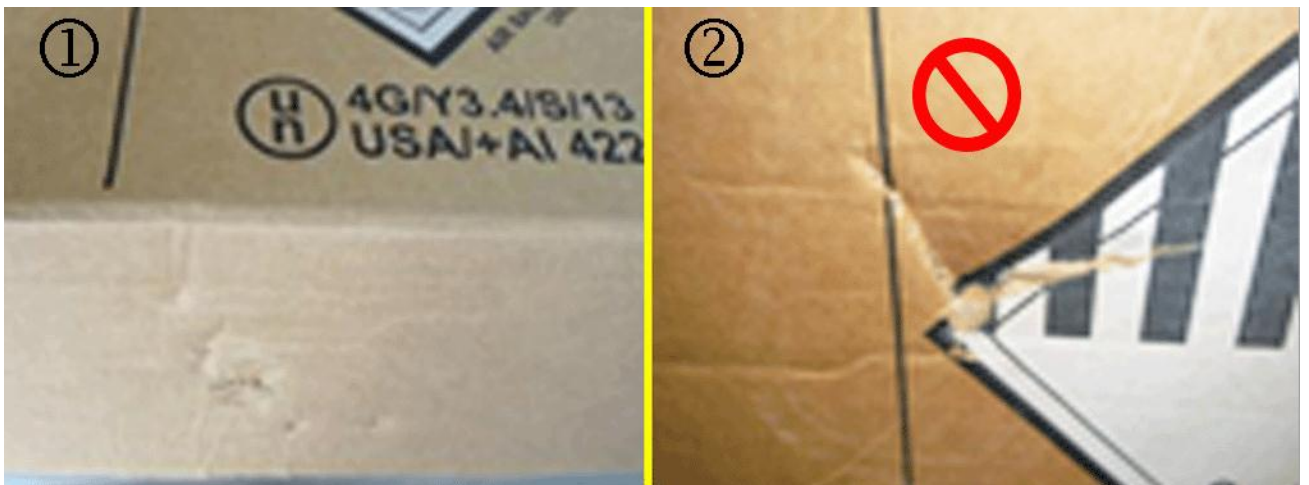
3961564

- **Dents:** Minor dents (1) occur through normal handling and picking (e.g. pulling from bin locations) and are acceptable. Major dents (2) result from impacts with others objects (e.g. pallet impacts).

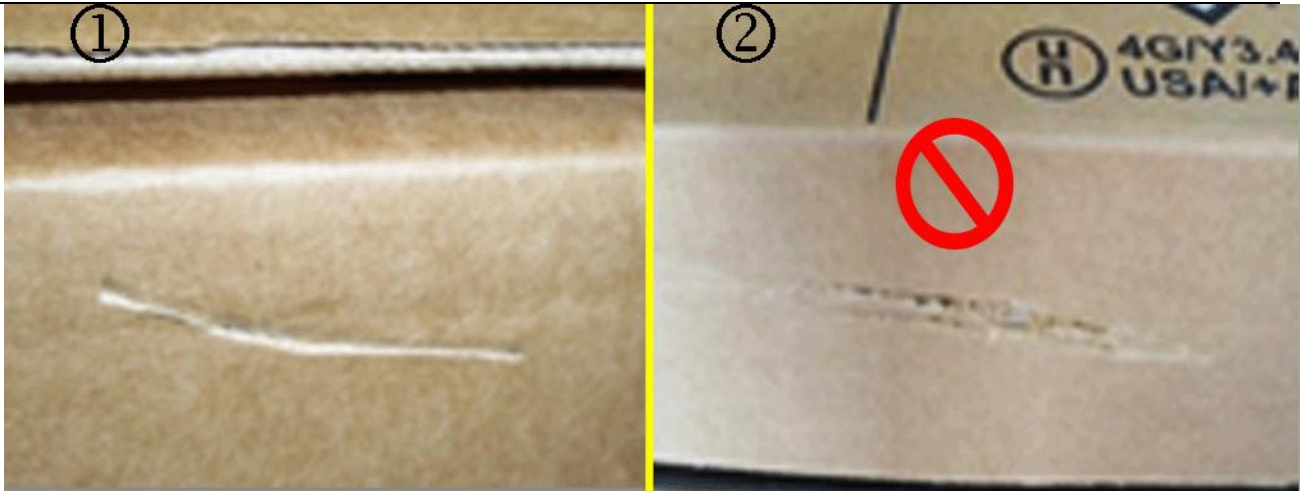
3961565

- **Incisions:** Minor incisions (1) are acceptable. Major incisions (2) (e.g. pallet box cut open with utility knife) are NOT acceptable.

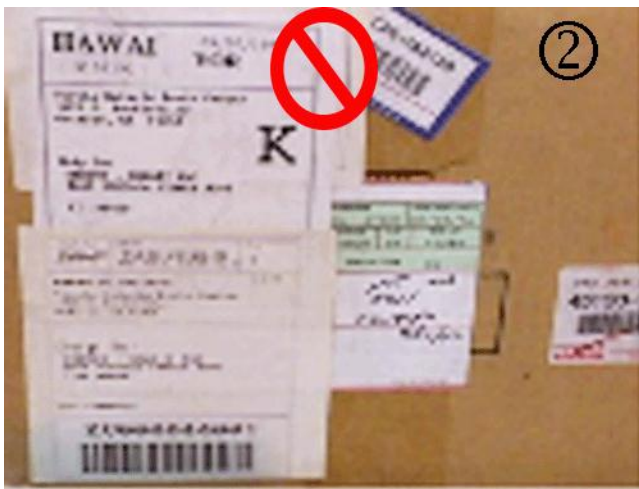
3961566

- **Labeling:** Packages with excessive labeling are NOT acceptable, particularly if the labels obscure other required marks and labels.

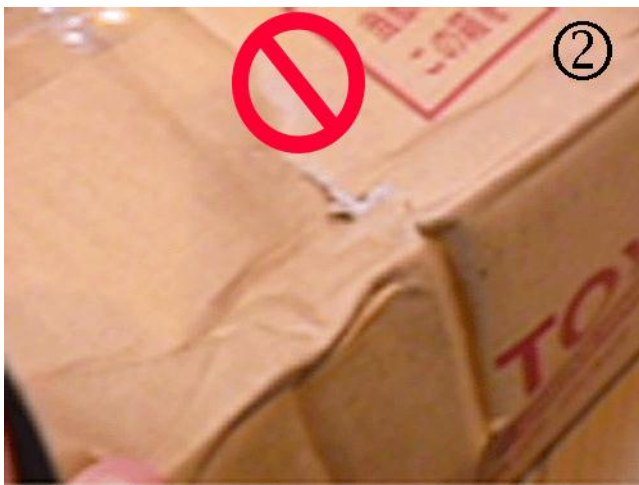
3961567

- **Other Damages:** Multiple damages, such as those shown above, may affect the integrity of the packages, and are NOT acceptable. Others that are not as severe may be acceptable. If questionable, repackage the material.

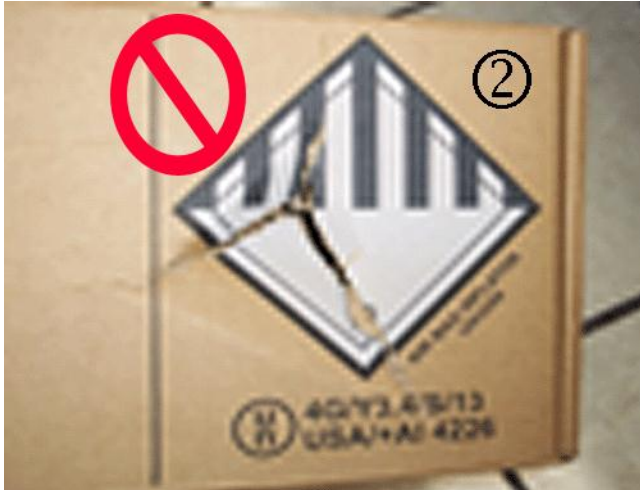
3961568

- **Punctures:** Any punctures, even minor ones, are NOT acceptable.

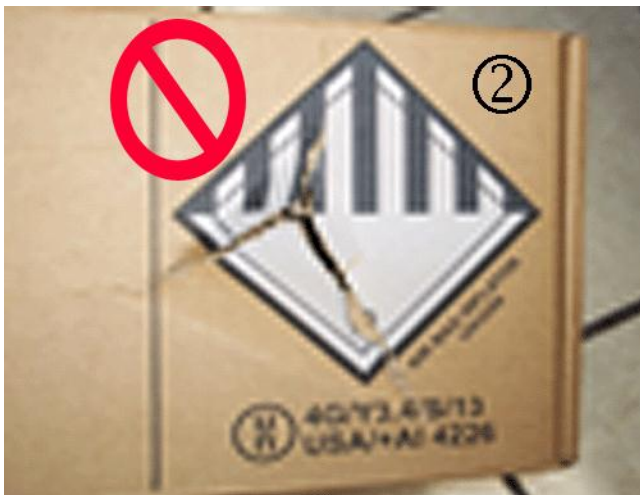
3961568

- **Tears:** Minor tears will not generally affect the structural integrity of the packaging and are considered to be normal "wear and tear", however, large tears or rips are NOT acceptable.

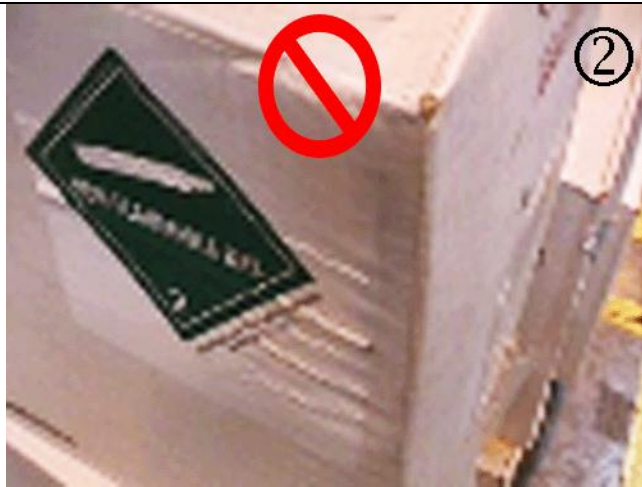
3961569

- **Water Damages:** Water Damages, such as the example shown above, are NOT acceptable. Water damages will affect the structural integrity of the packaging. These packages should be repacked in appropriate specification packages.
