# Recall Bulletin

## NONCOMPLIANCE RECALL

**SUBJECT:** Daytime Running Lights Disabled

**MODELS:** 2013 Cadillac ATS

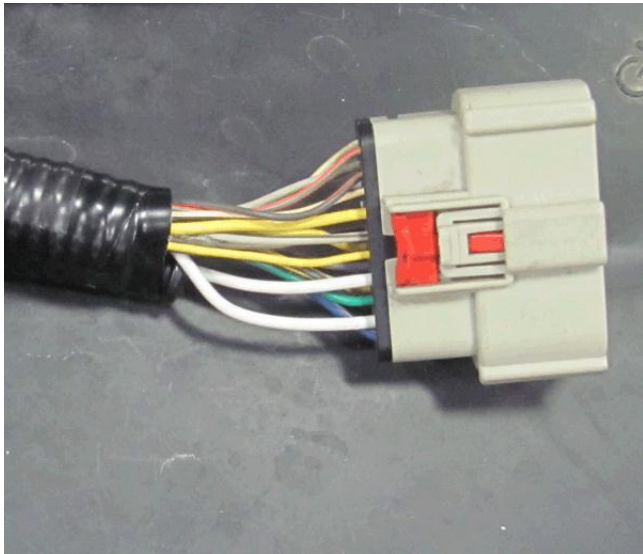
4001416

**X 126 body harness to forward lamp harness connector shown.**

11. Disassemble the X 126 body harness to forward lamp harness connector.
12. Install the brown wire (circuit 4357) with the terminal lead into PIN 7 of the X 126 body harness to forward lamp harness connector. Refer to *Connector End Views: X 126 Body Harness to Forward Lamp Harness* in SI.

13. Install the gray wire (circuit 4356) with the terminal lead into PIN 9 of the X 126 body harness to forward lamp harness connector. Refer to *Connector End Views: X 126 Body Harness to Forward Lamp Harness* in SI.
