Recall Bulletin

PRODUCT SAFETY RECALL

SUBJECT: Roof Carrier Retaining Nut Interaction with Roof Rail Airbag

MODELS: 2015 Chevrolet Suburban, Tahoe
2015 GMC Yukon, Yukon XL

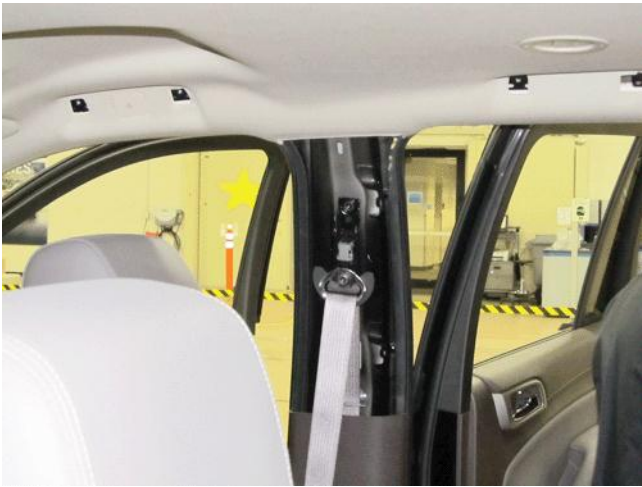
3960817

Note: When doing the headliner removal/install portion of the procedure noted below, the following is recommended:

- Working on one side at a time will allow you to reposition interfacing trim and work around the headliner better.
- Removing the forward most trim and accessories is not necessary.

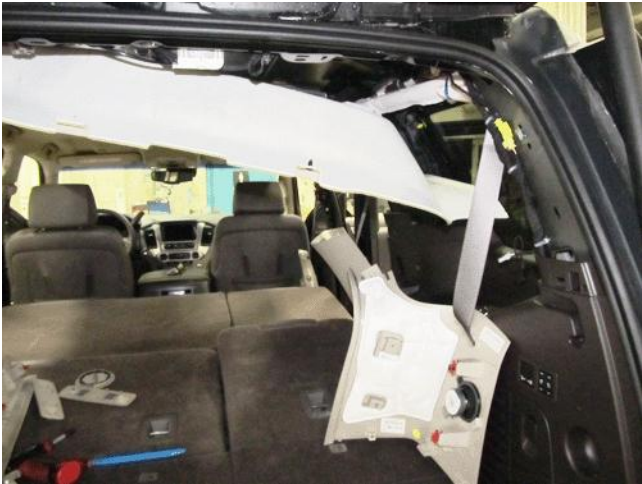
3960818

- Removing the assist handles, reading lamps, videos displays then detaching and repositioning upper pillar/quarter trim panels and headliner will allow the necessary access to the side rail fasteners.
