# Program Bulletin

## CUSTOMER SATISFACTION PROGRAM

**SUBJECT:** Manual Transmission Stuck in Gear

**MODELS:** 2014 Chevrolet Camaro  
Equipped with Manual Transmission (MG9, M10, MM6)

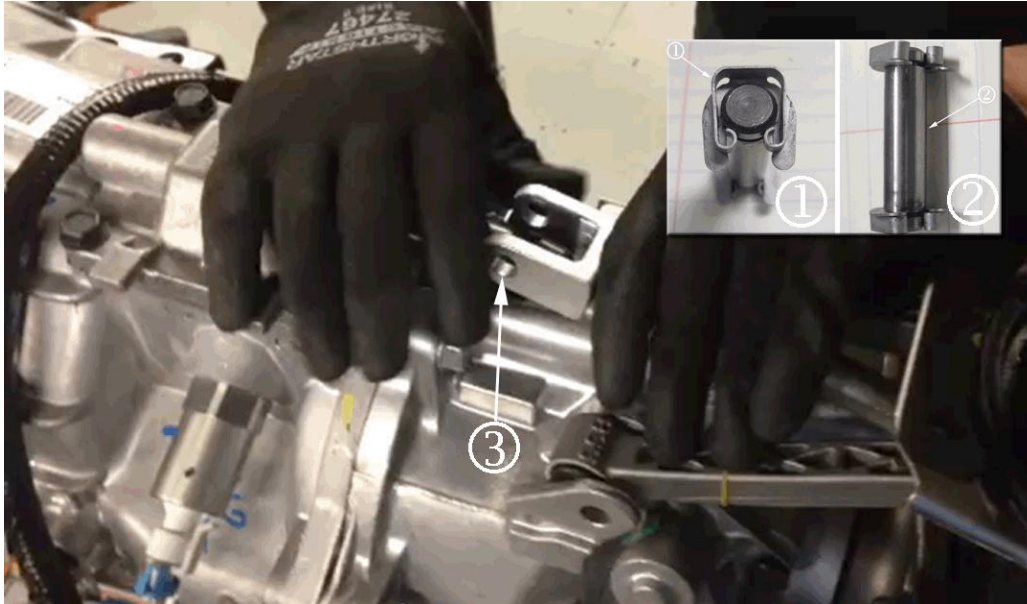
3959570

**Top side of the manual transmission shown on a work bench. The yoke connecting the shift mechanism to the transmission is installed with a linkage pin and two retaining clips.**

6. Install a new shift linkage pin assembly (2) and one additional retaining clip (1) into the yolk hole (3).
- 6.1 Install the linkage pin assembly (2) through the yolk hole (3).
- 6.2 Install the additional retaining clip (1) onto the linkage pin assembly end that does NOT have a retaining clip (1).
7. Install the transmission. Refer to *Transmission Replacement* in SI.
