# Service Bulletin

## SPECIAL COVERAGE

**SUBJECT: Special Coverage Adjustment – Improperly Formed Hood Panel Clinch Joints**

**MODELS: 2014 Buick Verano  
2014 Chevrolet Sonic**

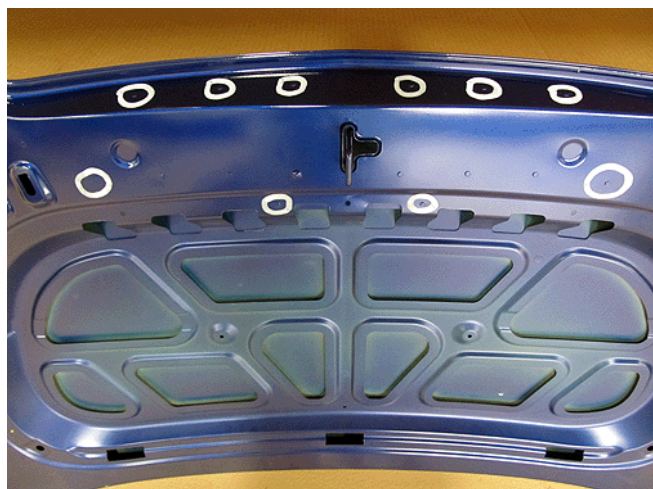
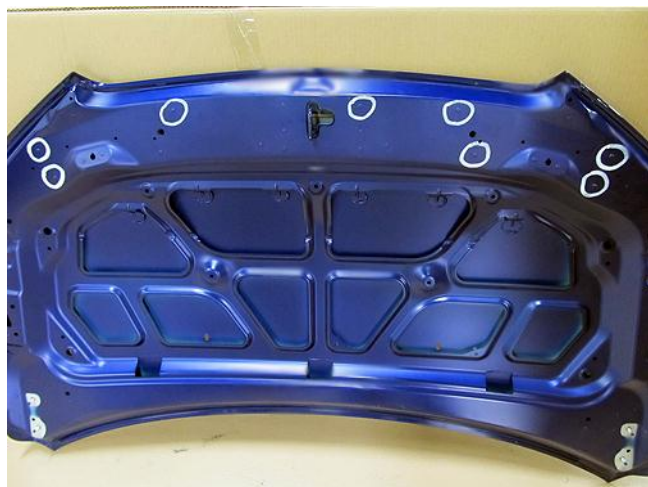
### **Verano Service Locations**

1. Remove the hood from the vehicle. Refer to *Hood Replacement* in SI. Place the hood on a suitable work surface.
2. Remove the hood insulator. Refer to *Hood Insulator Replacement* in SI.
3. Locate the clinch joints to be serviced, they are circled in white below.

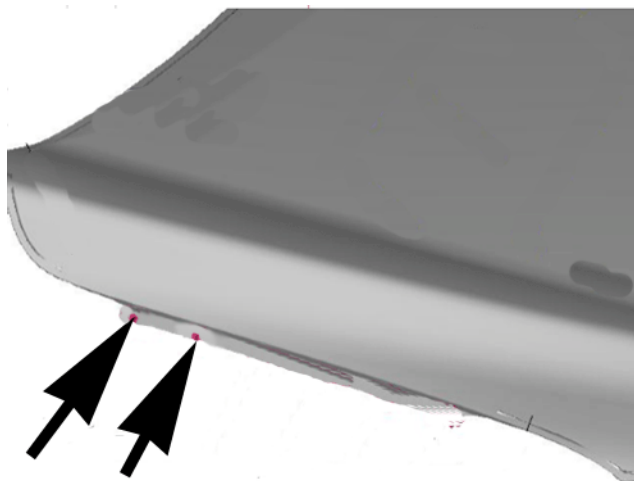
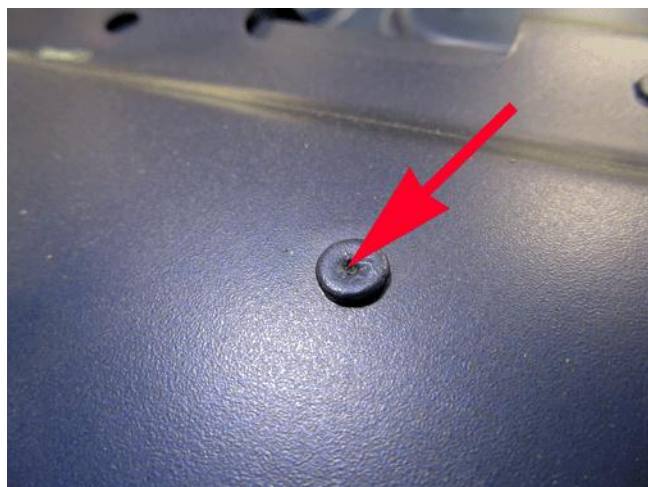
### Sonic Service Locations

**Note: On Sonic Vehicles, there are two clinch joint locations on the right rear of the hood in addition to the eight front locations.**
