Service Bulletin

SUBJECT: Service Update for Inventory and Customer Vehicles
Inspect Air Conditioning Refrigerant Warning Label and Adjust Refrigerant Charge
Expires with Base Warranty

MODELS: 2015 Cadillac Escalade and Escalade ESV Models
2015 Chevrolet Suburban and Tahoe Models
2015 GMC Yukon and Yukon XL Models

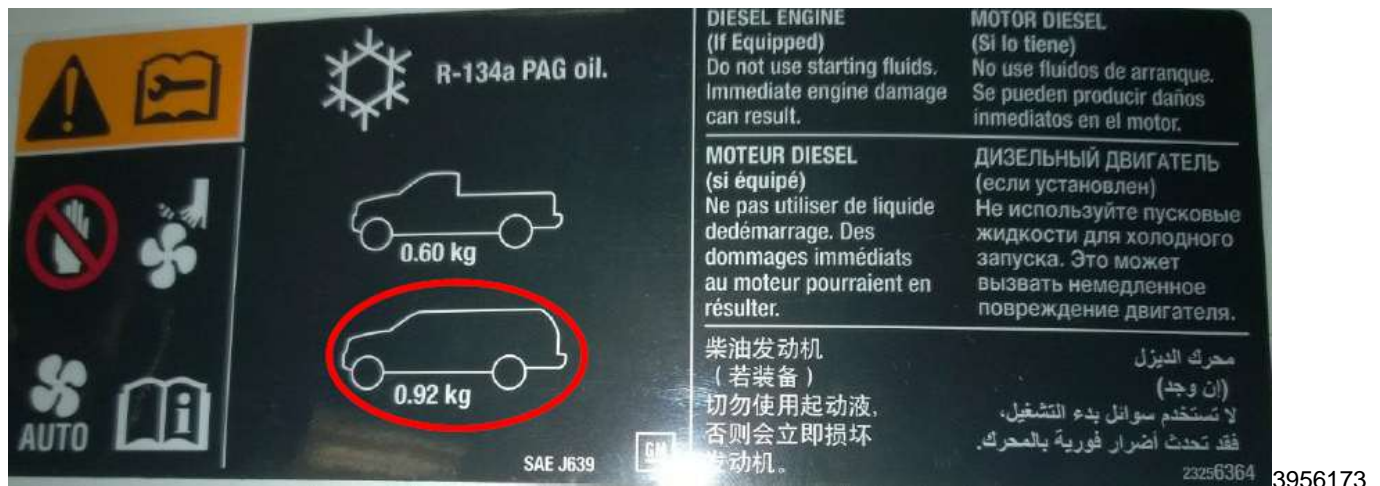
Example of Air Conditioning Refrigerant Warning Label with 0.92 kg Correctly Displayed

- Open the hood and inspect the air conditioning (A/C) refrigerant warning label shown above to ensure that it is correct.
 - If the refrigerant charge is listed as 0.92 kg as shown above, the air conditioning (A/C) refrigerant warning label is correct and no further action is required.
 - If the refrigerant charge is NOT listed as 0.92 kg, it is incorrect. Proceed to step 2.

- Completely recover the entire amount of original refrigerant from the air conditioning system and recharge it with the recovered refrigerant but exactly to the specified quantity of 0.92 kg only. Refer to *Refrigerant Recovery and Recharging (R-134a)* in SI.

3. Replace the incorrect air conditioning refrigerant warning label using the correct label described above.
