Recall Bulletin

PRODUCT SAFETY RECALL

SUBJECT: Rear Toe Link Adjuster Lock Nut Torque

MODELS: 2010-2015 Cadillac SRX
2011-2012 Saab 9-4X

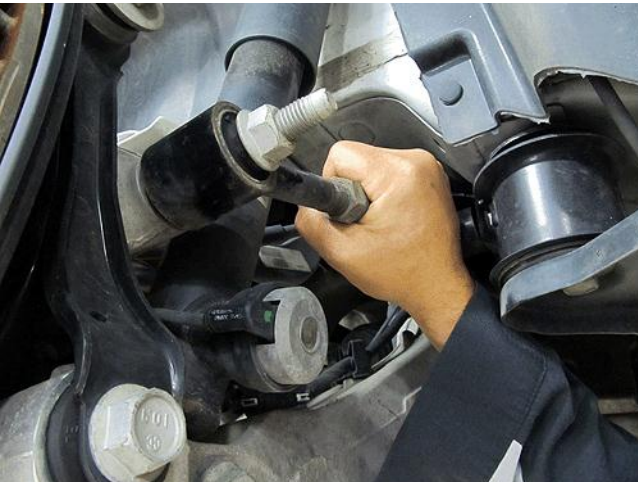
3979306

- Grasp the adjustment collar and push up and pull down firmly, note any movement in the link assembly components (the ends are rubber mounted and will have some movement)

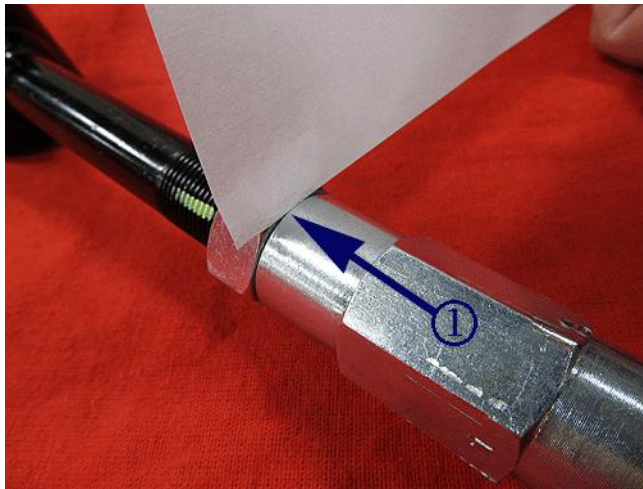
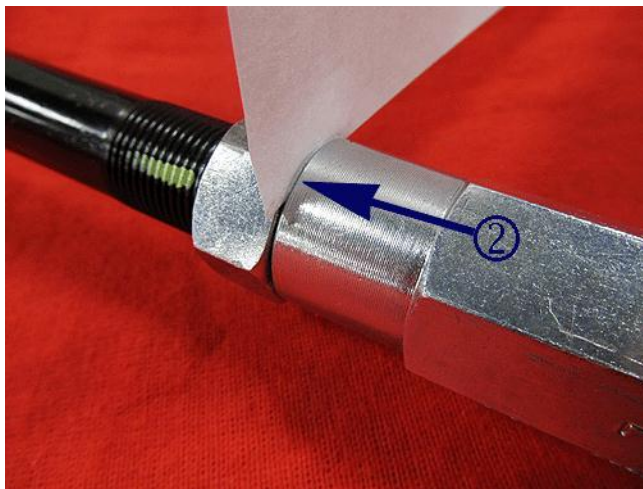
(1) Paper does NOT fit between jam nut and rear suspension adjustment link. (2) Paper fits between jam nut and rear suspension adjustment link.

- Inspect the toe link assembly for loosened jam nuts. Use a piece of paper to determine if there is a gap between the jam nut and the adjustment collar.
5. If the adjustment link fails any of the above tests, replace the adjustment link assembly. Refer to *Adjust Link Replacement* in SI.
