Service Bulletin

SUBJECT: Service Update for Inventory and Customer Vehicles
Hood Latch Striker Weld
Expires with Base Warranty

MODELS: 2015 Cadillac ATS

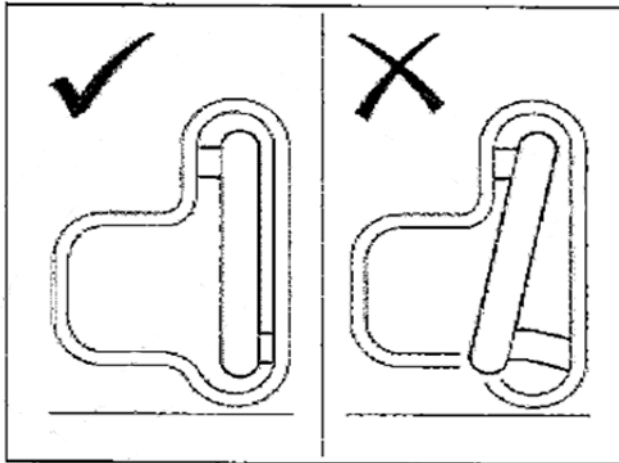
3975749

5. Verify that the striker is not loose or bent, as shown in the example above.

- If the hood striker does NOT show any looseness or bending, no further action is required; just verify the hood closes properly.
- If the hood striker DOES show looseness or bending, continue on to the *Hood Replacement Procedure* below.
