Program Bulletin

CUSTOMER SATISFACTION PROGRAM

SUBJECT: Auxiliary Transmission Cooler Line

MODELS: 2014 Chevrolet Corvette Convertible

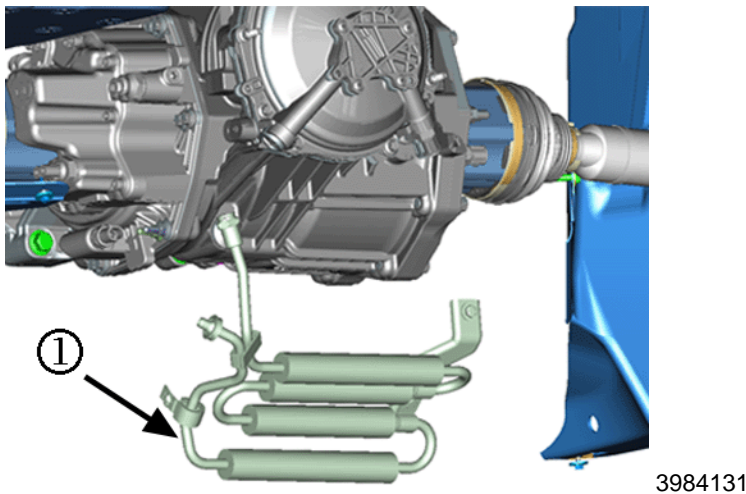
Certain 2014 model year Chevrolet Corvette convertible vehicles have a cooler outlet connector pipe on the auxiliary transmission cooler that may not be properly sealed to its mating connection. The improper seal may cause transmission oil to leak or, under certain conditions, the connector pipe to disconnect from the mating connection. The disconnection of the connector pipe may result in a loss of vehicle propulsion, and leaking transmission oil could cause smoldering if it contacts the heated intake exhaust pipes or mufflers.

1. Remove the transmission fluid auxiliary cooler (1). Refer to *Transmission Fluid Auxiliary Cooler Replacement (MEL / MEP Convertible) or (MYC Convertible)* in SI.
2. Install the new transmission fluid auxiliary cooler. Refer to *Transmission Fluid Auxiliary Cooler Replacement (MEL / MEP Convertible) or (MYC Convertible)* in SI.
