UPDATE Technical Bulletin

UPDATE – 97AS Driver Seat Harness (NVLW)

Model(s)	Year	Engine Code	Trans. Code
Golf, GTI	2015	All	All

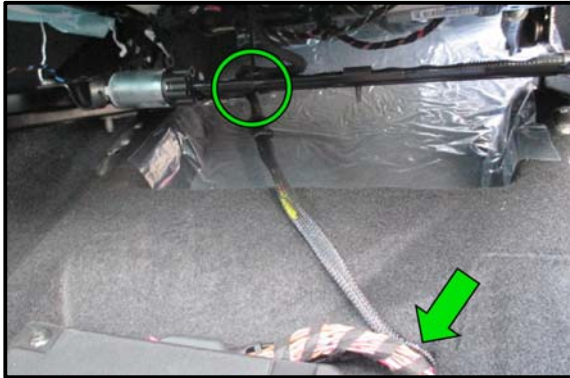
During vehicle production, the driver side power seat harness as it connects to the vehicle may have been incorrectly routed. Damage to the harness for the driver side power seat can occur during operation of the seat adjustments.

⇐ The wiring harness must be routed through the carpet on the inboard side of the access panel <arrow>, then **under** the seat frame as shown <circle>.

- If the harness is routed as pictured, the routing is **correct – Work Complete**
- If the harness is not routed as pictured, the routing is **incorrect**. Inspect the wiring harness for any visible damage.
 - If no damage is found, **Proceed to Section C – Seat Harness Re-routing.**
 - If damage is found, **Proceed to Section D – Seat Harness Replacement.**

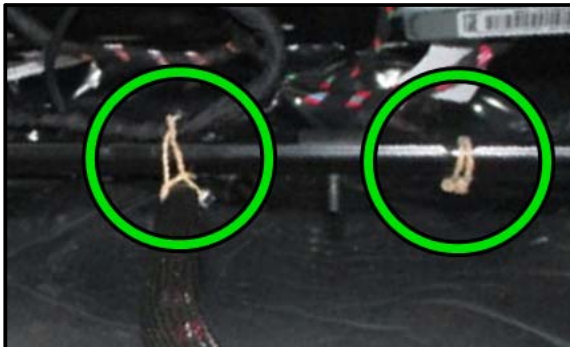
Tip: If rubber bands are found on the wire harness or seat frame <circles>, they can be removed and discarded.
