Technical Service Bulletin

GROUP
CAMPAIGN
14-01-038-1

MODEL(S)
ELANTRA SEDAN

SUBJECT: OVERHEAD CONSOLE SUNGLASS HOLDER LATCH REPLACEMENT PROCEDURE, (SERVICE CAMPAIGN TU1)

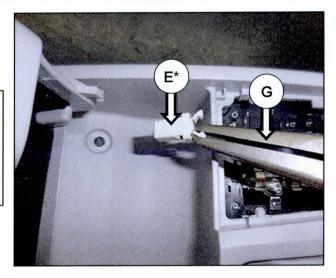
7. Insert the new holder latch (E*) with needle nose pliers (G) in the orientation shown.

Before installation, compare the orientation of the holder latch (E*) with the picture on the right. The slotted side should be facing away from your view.

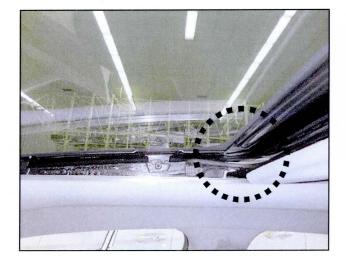
- 1. Start the sunroof reset procedure under the following conditions:
 - Sunshade open
 - Sunroof glass closed

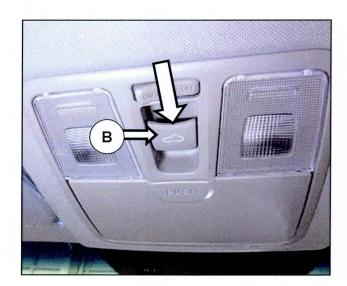
3. Push and hold the sunroof glass switch (B) forward in the direction of close for 10 seconds.

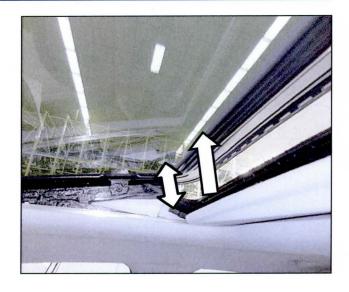
4. Keep holding the switch until the sunroof glass automatically tilts up and then moves up/down slightly.

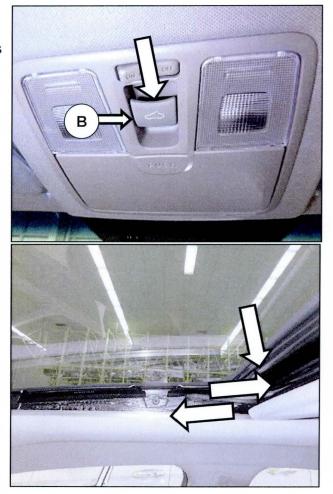
- 5. After the sunroof glass moves in Step 4, release the sunroof switch (B).
- 6. Within 3 seconds of releasing the switch (B), push and hold the switch (B) forward in the direction of close again until the sunroof glass moves as follows:
 - Tilt down → Slide open → Slide close

DO NOT release the control lever (B) until the operation is completed. If you release the control lever (B) during the operation, you must restart the sunroof resetting procedure.
