SERVICE BULLETIN

APPLICABILITY: 2014MY XV Crosstrek Hybrid (HEV)
SUBJECT: Revised Rear Combination Lamp to Prevent Condensation

NUMBER: 07-81-14
DATE: 02/03/14

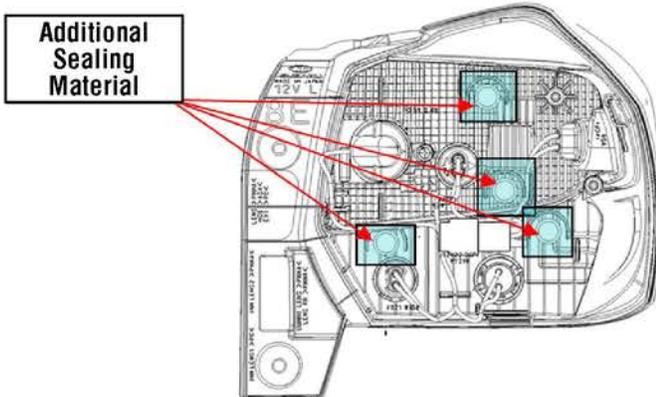
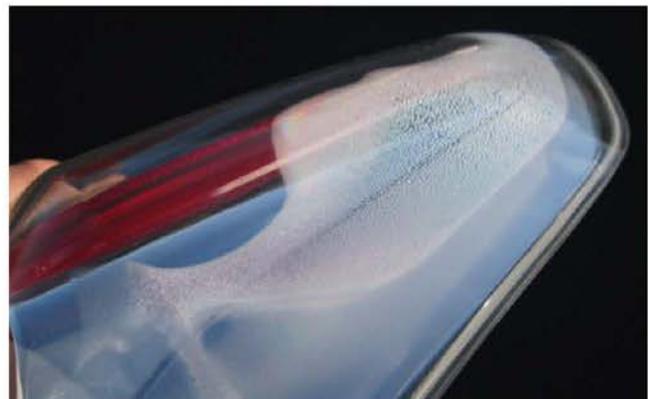
A revised rear combination lamp assembly has been developed which utilizes additional sealing material in four areas designed to prevent condensation from occurring on the inside of the housing. When performing this procedure, replace BOTH rear combination lamps at the same time.
