SERVICE BULLETIN

APPLICABILITY: 2008MY and Later Impreza, WRX and STI
2009MY and Later Forester M/T Equipped Vehicles
with Hill Start Assist

NUMBER: 03-72-14

SUBJECT: Hill Start Assist (HSA) Warning Light, DTC C0076

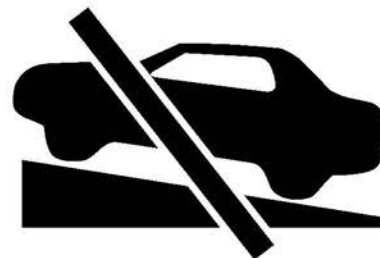
This bulletin provides information to address a customer concern of intermittent operation of the Hill Start Assist warning lamp. When the HSA warning lamp is illuminated, the hill start assist system is inoperative. DTC C0076 may be stored in memory along with detail codes 2610H and / or 2620H. All of these codes refer to the operation of the clutch switches.

- For detail code 2610H, check the clutch pedal switch signal using the SSMIII following the procedure in the applicable Service Manual.
- For detail code 2620H, check the clutch pedal switch clearance following the procedure in the applicable Service Manual.
