# Technical Service Bulletin

## 70 Noises from the upper-center dashboard area

70 14 36 2029280/3 March 31, 2014. Supersedes Technical Service Bulletin Group 70 number 13-33 dated July 12, 2013 for reasons listed below.

Model(s)	Year	VIN Range	Vehicle-Specific Equipment
A6, A7	2012	000001 - 151934	Not Applicable

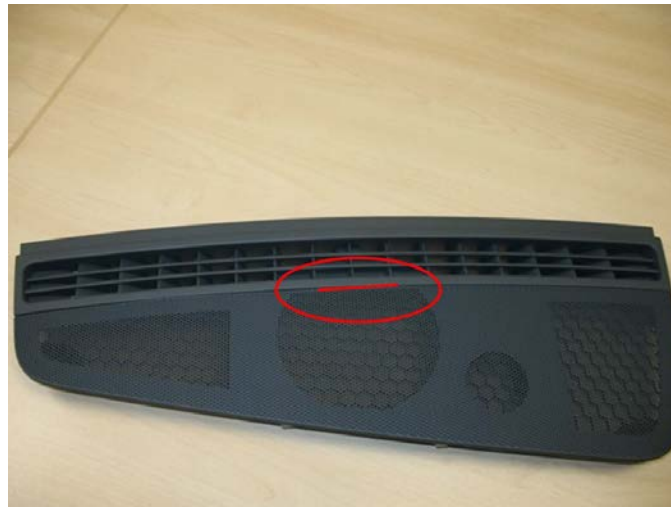
The noise can be caused by unfavorable tolerances between the instrument panel speaker and the center speaker trim. A speaker that has been incorrectly installed can make the condition worse.

Because there is no attachment to the trim carrier in the speaker cut-out, this area is the likely source of the vibration (Figure 1).

**Figure 1.** The affected area of the speaker grille, circled in red.

Replace the center defroster vent and the speaker trim. Review the steps below before proceeding:

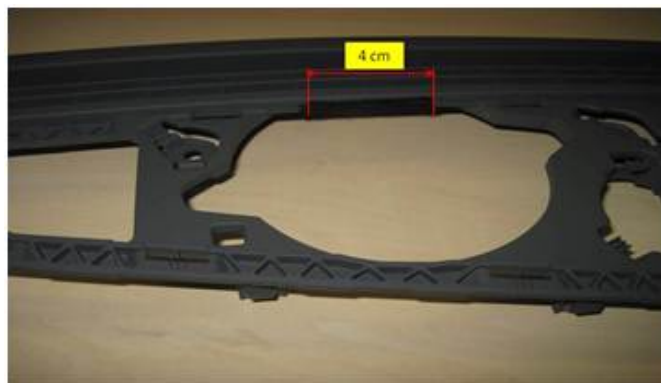
**Figure 2.** The felt tape should be applied to the area of the center defroster vent shown in red.

1. Before installing the vent and trim, cut a piece of felt tape (**D 373125A2**) to 40mm in length and 10mm in width.
2. Apply the piece of felt tape to the area of the center defroster vent shown (Figure 2).

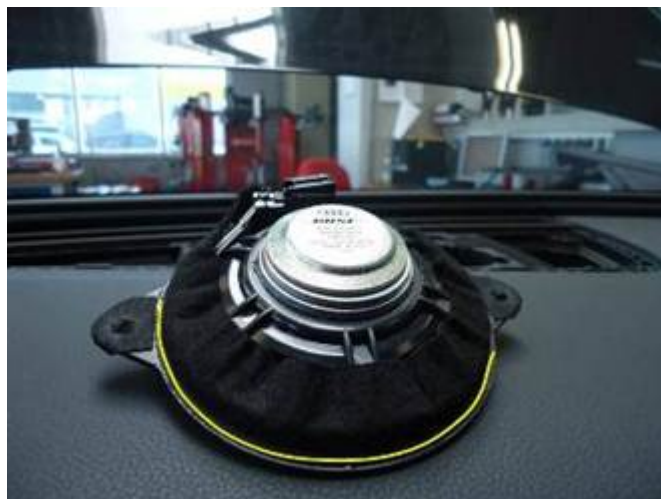
**Figure 3.** Area of speaker where felt tape is to be applied.

3. Remove the center speaker and apply felt tape to its perimeter (Figure 3).

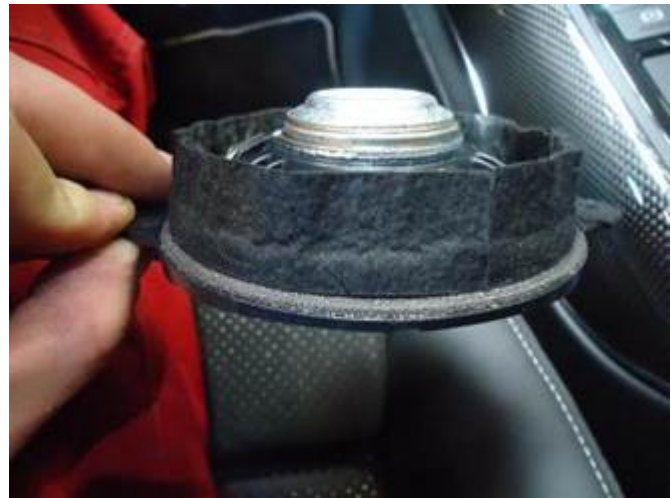
**Figure 4.** Center speaker with felt tape applied.

4. Ensure that the complete contact surface, including the mounting flanges, is isolated with the felt tape (Figure 4).
