SERVICE BULLETIN

APPLICABILITY: 2015MY WRX and STI Models
SUBJECT: Paint Chipping Due To Trunk Lid Movement

NUMBER: 12-172-14R
DATE: 07/11/14
REVISED: 07/15/14

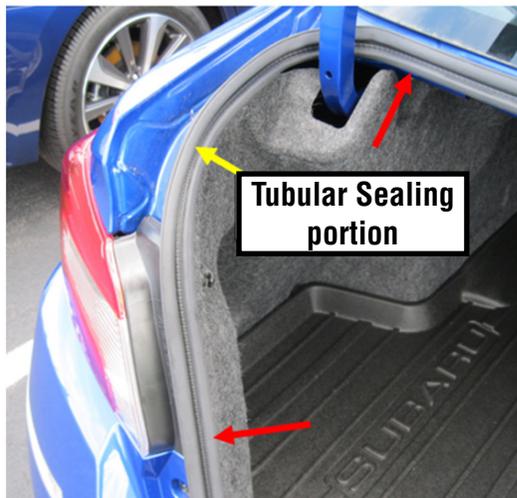
For STI models, in addition to the longer trunk stoppers, the trunk weatherstrip's tubular sealing portion now has internal reinforcement in the area between the red arrows shown in the photo below. This reinforcement serves to stabilize the trunk panel and eliminate the chipping.

- Updated trunk weatherstrip, p.n. **57532VA002**- Qty. 1
- Replacement Trunk Lid Stoppers - Qty. 2
 (NOTE: currently, these are BRZ trunk stoppers, p.n. **57533FE040**)

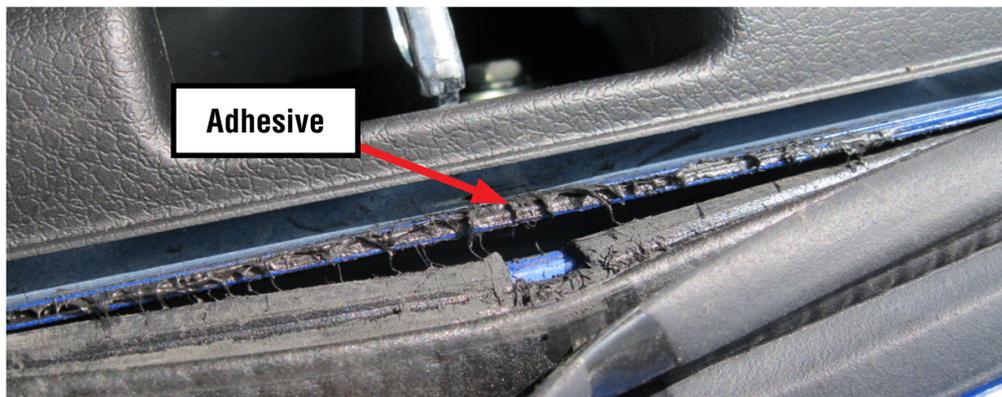
- **BE CAREFUL** to not tear the rubber material of the trunk weatherstrip when removing or re-positioning the replacement part.
- When removing the original weatherstrip, be careful to not get any of the adhesive as shown below on the trunk liner trim panels.

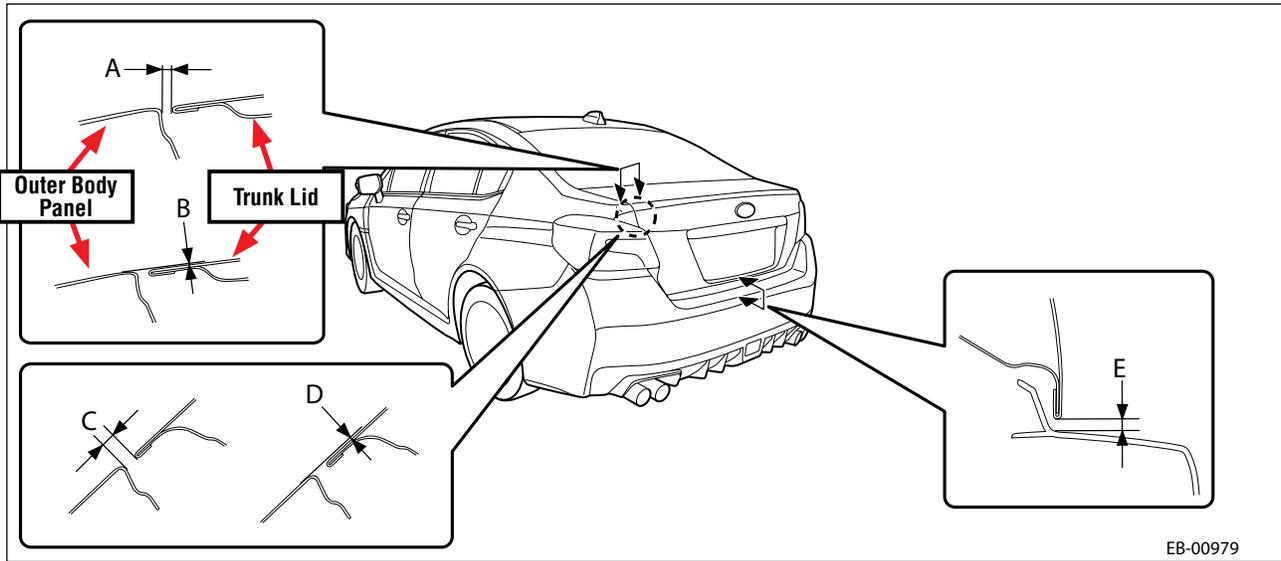
- After the trunk lid is closed, look closely for any excessive, insufficient or uneven gap(s) around the complete perimeter of the trunk lid.
- Make sure the trunk height is correct and that it fits “flush” with the corresponding edges of the rear quarter panels.
- In most cases, there should be only **minor** adjustment needed to the trunk lid, if any at all. Pay close attention to the adjustment for “**B**” as shown in the table below. If after close inspection, it is determined adjustment of the trunk lid is necessary for proper fit, use the Service Manual specifications supplied below **EXCEPT FOR “B”** which has been recently revised (shown in RED). The Service Manual will be updated with the revised specifications in the near future.

Part		Standard
A	Trunk lid COMPL and Panel - side outer	3.5±1.0 mm (0.14±0.04 in)
B	Surface level gap between Trunk lid COMPL and Panel - side outer (Difference in height)	0+.5 mm (.020") by adjusting the striker -STI
C	Trunk lid COMPL and Panel - side outer	3.5±1.0 mm (0.14±0.04 in)
D	Surface level gap between Trunk lid COMPL and Panel - side outer	-0.5±0.7 mm (0.02±0.03 in)
E	Trunk lid COMPL to Bumper face - rear	7.5±1.0 mm (0.3±0.04 in)
