SERVICE BULLETIN

APPLICABILITY: 2015 Legacy and Outback Models

NUMBER: 10-80-14

SUBJECT: Whistling Sound from Side Dash Vents

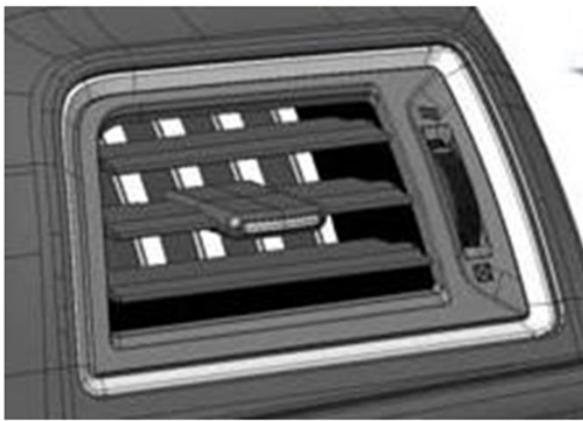
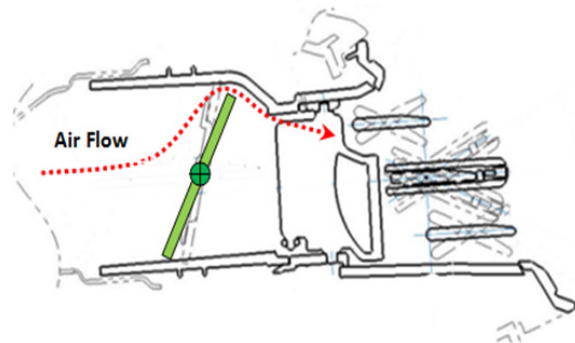
This bulletin provides a service procedure to address a customer concern of a whistling sound coming from the side dash vents when their air flow is adjusted to almost the fully closed position.

Side dash vent shown in almost fully closed position
