TECHNICAL BULLETIN
Q238NAS2
18 JUN 2014

Service Action: Rear Spoiler Load Spreading Bracket

Range Rover Sport (LS)

Model Year: 2012-2013
VIN: CA717173-DA764544

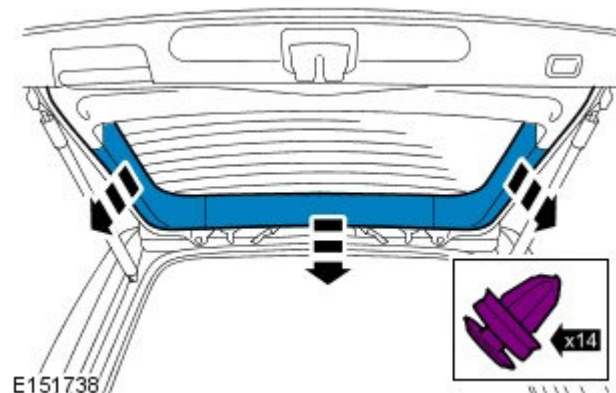
1. Open the tailgate.
2. Remove the three (3) trim panels.
 - Release the 14 clips.

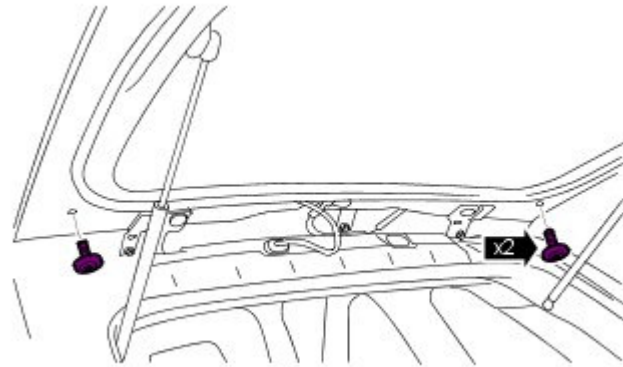
E137711

3. Remove the two (2) fixing bolts.

- Tighten to 6.5Nm.

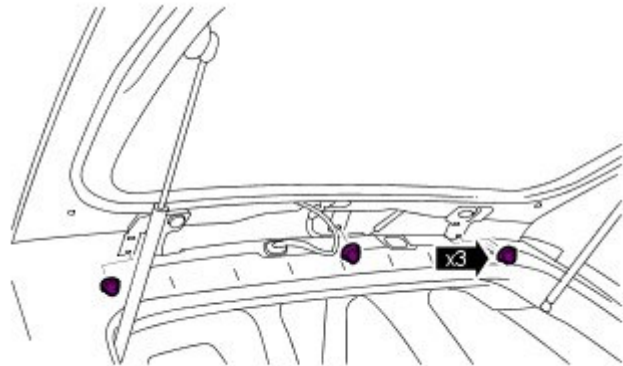
E137712

4. Remove the three (3) fixing nuts.

- Tighten to 8Nm.

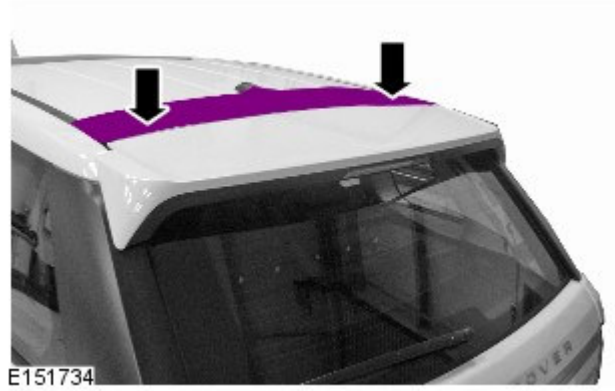
Apply protection as shown.

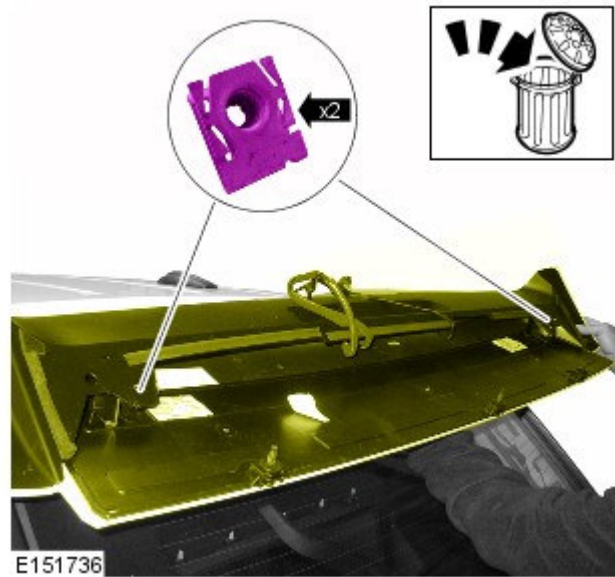
7. Remove the two (2) clips.

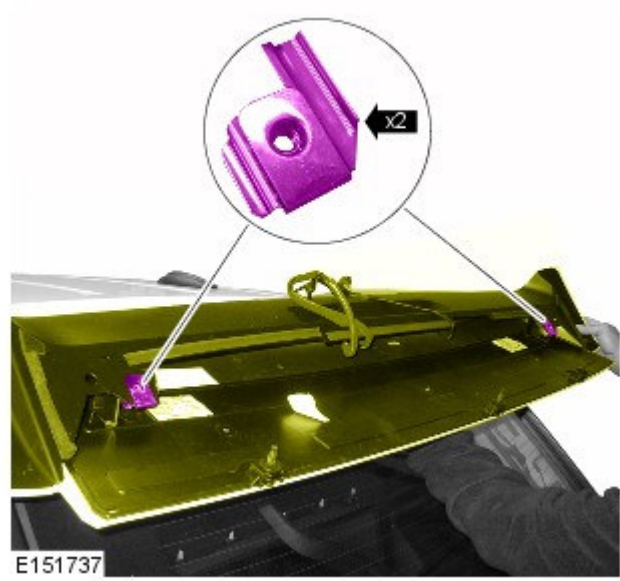
8. Install the two (2) new clips.
