TECHNICAL BULLETIN  
Q382NAS1  
03 JUN 2014

Service Action: Front Suspension Lower Control Arm-to-Knuckle Nut

**Range Rover Evoque (LV)**  
**Model Year:** 2014  
**VIN:** EH888926-EH903896

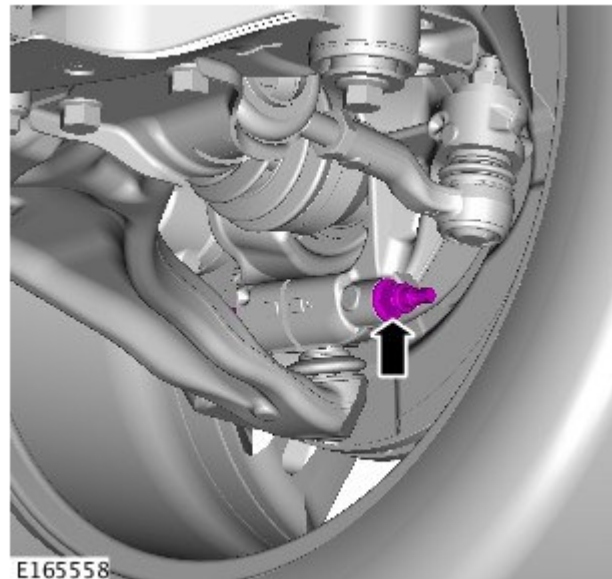
2.

**Situation:** An issue has been identified on a number of 2014 model year Range Rover Evoque (L538) vehicles within the listed VIN range which may have been manufactured away from process with an incorrect torque specification of the front suspension lower control arm-to-knuckle retaining nuts.

**NOTE: Front right shown; front left similar.**

Torque the front suspension right-hand lower control arm-to-knuckle retaining nut to 175Nm.

3. Torque the front suspension left-hand lower control arm-to-knuckle retaining nut to 175Nm.
4. Lower the vehicle.
