TECHNICAL BULLETIN
Q384NAS1
13 JUN 2014

Service Action: Trailer Harness Central Junction Box Connector Pin Locations

LR4 (LA)
Model Year: 2014
VIN: EA699718-EA713882

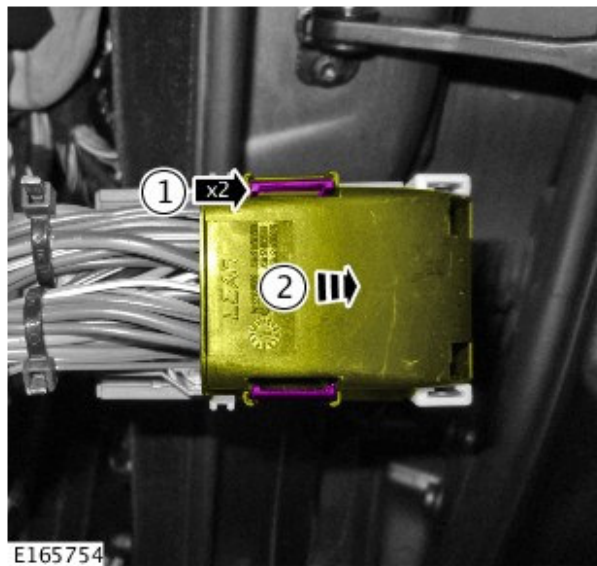
**NOTE: Electrical connector number 0585L - Brown.**

Release the electrical connector cover from the electrical connector.

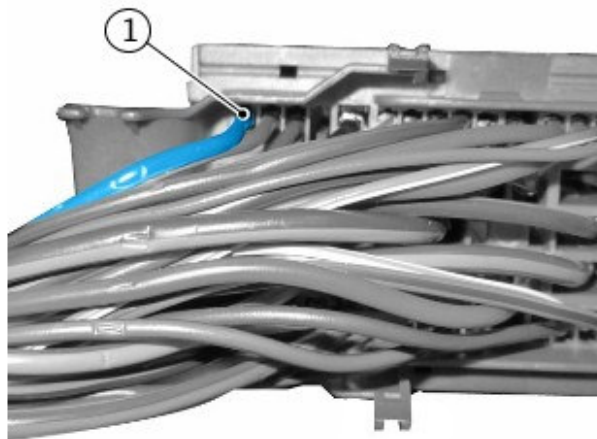
E165757

Situation: An issue has been identified on a limited number of 2014 model year LR4 (L319) vehicles within the listed VIN range where the Central Junction Box (CJB) connector has incorrect pin assignments. The CJB connector has pin location '1' wired in error where pin location '44' should be wired. If a trailer wiring harness is installed, the trailer's side and outer marker lamps do not illuminate.

7. Using the release tool 418-593 from the Terminal Repair Kit, remove the wire and terminal from cavity (1) of the connector.
