NUMBER: 19-002-14

GROUP: Steering

Steering Column Squeak / Moan While Turning Wheel

2014	LC	Challenger
2014	LD	Charger
2014	LX	300

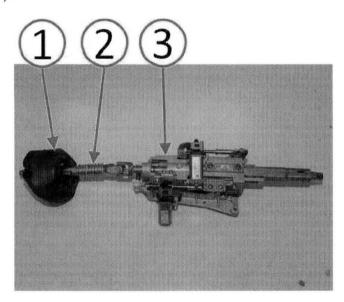
Fig. 1 Steering Column Assembly

- 1 Bulkhead Pass Through Boot
- 2 Intermediate Shaft

3 - Steering Column

Remove the steering column assembly (1, 2, 3) from the vehicle. Discard intermediate shaft pinch bolt. Refer to the detailed service procedures available in DealerCONNECT> TechCONNECT under: Service Info> 19 - Steering> Column> Removal (Fig. 1).

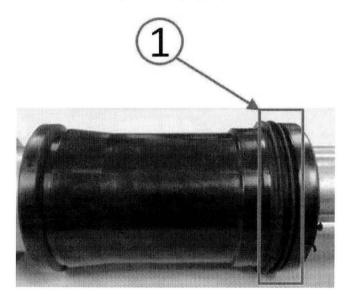
Fig. 3 Wiper Seal To Be Removed

1 - Wiper Seal

- 1 Bulkhead Pass Through Boot
- 2 Inner Bearing Sleeve
- 3. Completely remove the rubber wiper seal (Fig. 3).

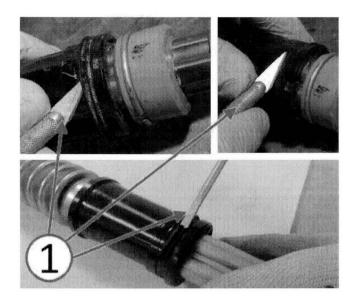
Fig. 4 Wiper Seal Removal

1 - Wiper Seal Removal Tools

4. Using an appropriate tool, cut and/or scrap the rubber wiper seal from the plastic inner bearing sleeve (Fig. 4).

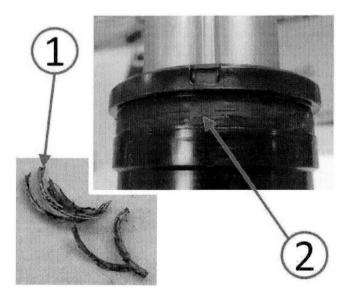
Fig. 5 Wiper Seal Removed

1 - Wiper Seal Pieces

2 - Inner Bearing Sleeve With Wiper Seal Removed

5. Ensure that the rubber wiper seal (1) has been completely removed from the plastic inner bearing sleeve (2) (Fig. 5).

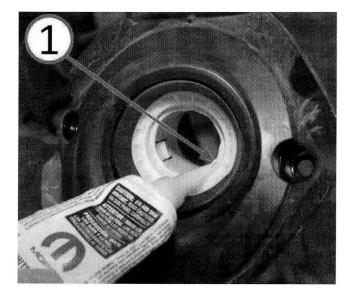
Fig. 7 Apply White Lithium To Outer Bearing Sleeve

1 - White Lithium Grease

- 1 White Lithium Grease
- 7. Apply white lithium grease to the contact surface at each end of the outer bearing sleeve (Fig. 7).

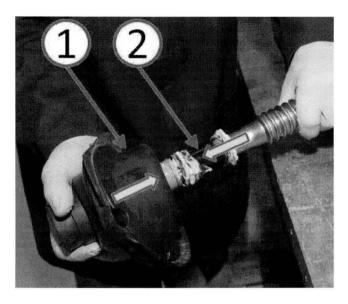
Fig. 8 Install Boot To Intermediate Shaft

1 - Bulkhead Pass Through Boot

2 - Inner Bearing Sleeve

8. Use a quick push action to install the intermediate shaft bulkhead pass through boot and outer bearing sleeve assembly (1) to the intermediate shaft inner bearing sleeve (2) (Fig. 8).

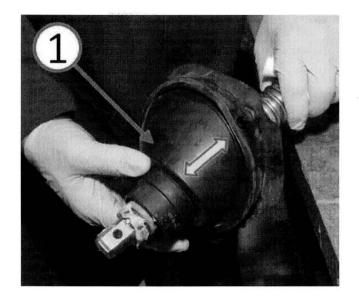
Fig. 9 Check Installation

1 - Bulkhead Pass Through Boot

9. Slide the intermediate shaft bulkhead pass through boot and outer bearing sleeve assembly back and fourth to distribute the white lithium grease and to ensure that the outer bearing sleeve is properly engaged with the inner bearing sleeve (Fig. 9).
