PRODUCT CAMPAIGN BULLETIN

APPLICABILITY: 2003-2005 Subaru Legacy and Outback
 2003-2005 Subaru Baja
 2004-2005 Subaru Impreza
 (including WRX and STI)

NUMBER: WQM-49
DATE: September 2014
NHTSA ID: 14V-471

SUBJECT: Regional Front Passenger Air Bag Inflator Replacement

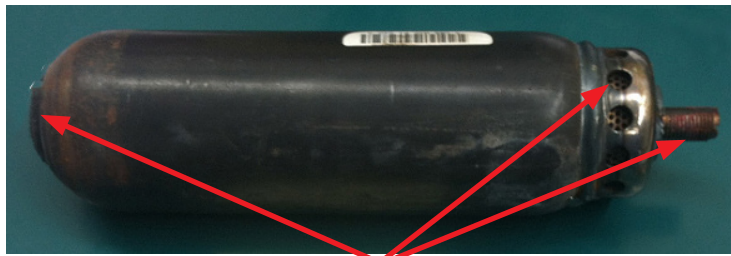
The shape, holes, and copper-colored stud indicate this not a Genuine Subaru inflator.

- **Do not proceed with this repair if your inspection reveals a non-Genuine Subaru air bag module has been installed in the vehicle.** Follow the instructions described in the “Counterfeit Air Bag Information” Dealer Advisory Bulletin and contact the SOA Warranty Helpline to close out the WQL-48 recall coverage on the vehicle.

- Document the presence of the aftermarket or counterfeit device on the repair order and with photos. Report this information immediately on a Quality Monitoring Report (QMR).

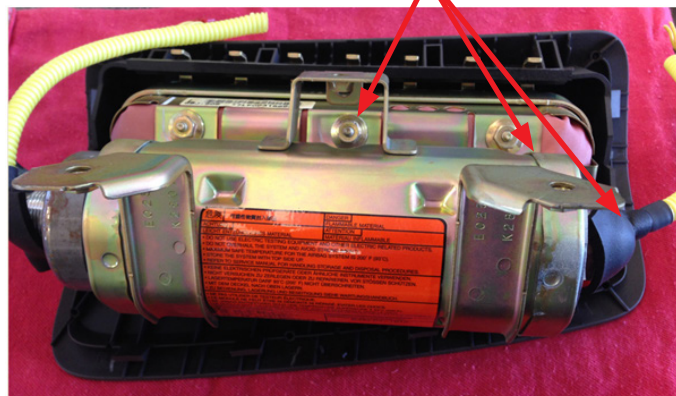
No visible stopper plates, a 6-nut configuration and rubber harness boots are other examples to indicate this is not a Genuine Subaru airbag module.
