**PRODUCT CAMPAIGN BULLETIN**

**APPLICABILITY:** 2015 Subaru Outback  
**SUBJECT:** 2015 Outback Accessory Trailer Hitch Assembly

**NUMBER:** WQN-50  
**DATE:** October 2014  
**NHTSA ID:** 14V-577

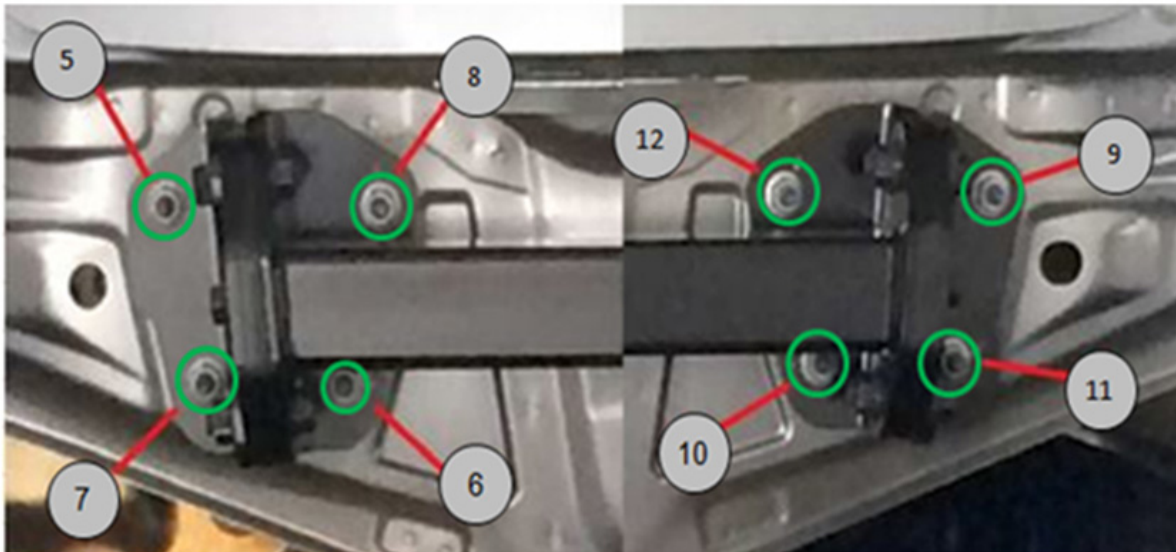
- Once the rear bumper fascia has been removed, remove each of the eight M10 (15mm hex) retaining nuts (circled in green below) securing the hitch frame to the stud bolts **one at a time** using **HAND TOOLS ONLY**. As each nut is removed, inspect the flange portion of the nut for a stamping mark as follows:

- If any of the nuts have stamping marks other than an “S”, the hitch frame must be removed and the stud bolt threads must be closely inspected for damage.

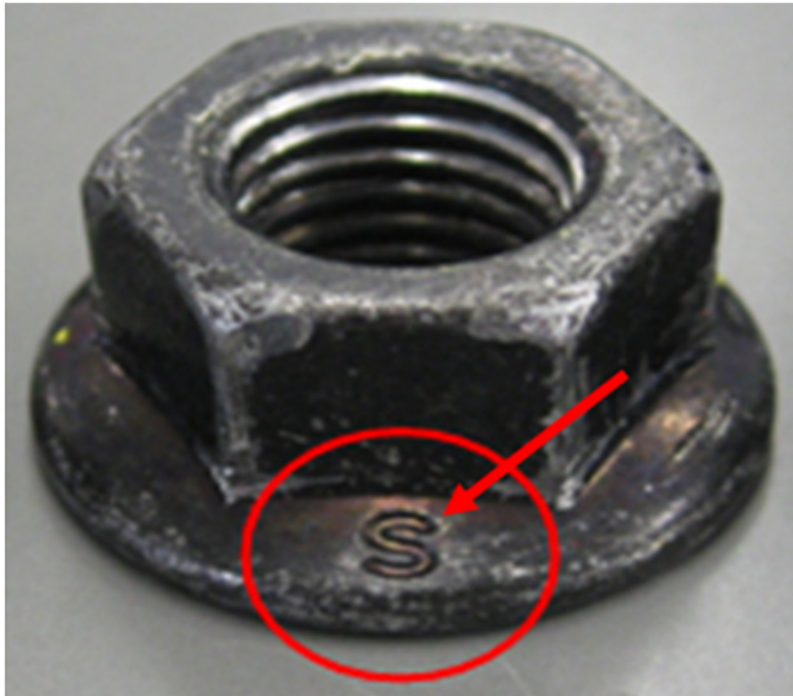
- If all eight removed nuts have an “S” stamping mark on them as shown below, replace them with the **GRAY** nuts included in the Hitch Repair Kit and torque to 51 ft. lbs. **in the sequence shown in the chart on pg. 8 (5-12)**. Once all of the new **GRAY** nuts have been installed, skip ahead to **STEP 7** to complete the campaign service procedure.

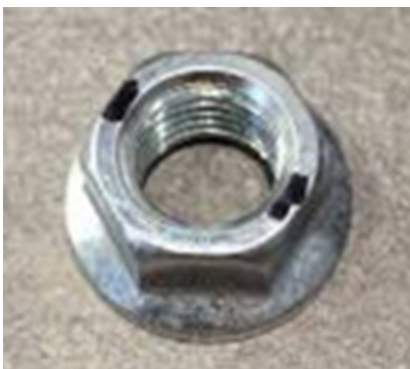
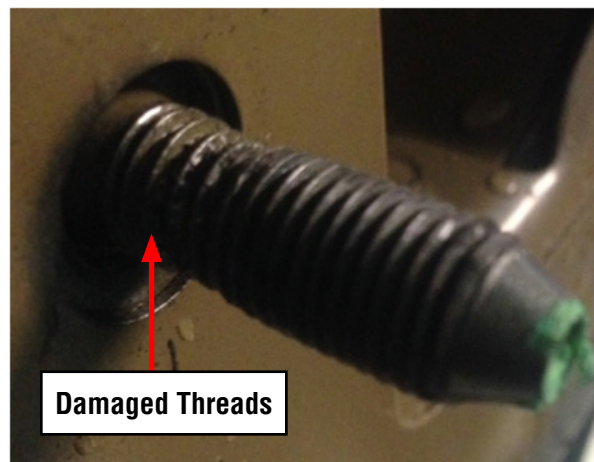
**Trial Nut  
(Bright silver finish)**

- Inspect the threads of each stud bolt for damage.
  - o If severe damage to the threads is confirmed as shown in the example photo below, the affected stud bolt(s) must be replaced.
  - o If the threads do not appear to be severely damaged, take one of the bright silver Trial Nuts from the Hitch Repair Kit and thread it onto the stud bolt by hand. A 15mm socket can also be used to turn the nut by hand only (no ratchet or other turning tools). Thread the Trial Nut all the way onto the stud bolt until it contacts the body. If the Trial Nut can be threaded onto the stud bolt BY HAND, the stud bolt does not need to be replaced. Inspect all the stud bolts using the four bright silver Trial nuts included in the Hitch Repair Kit. Each Trial Nut should only be used twice (to test only two stud bolts).

- If the Trial Nut cannot be threaded all the way on by hand as described above, the affected stud bolt(s) will need to be replaced. Mark the affected stud bolt(s) with paint to identify them for replacement.

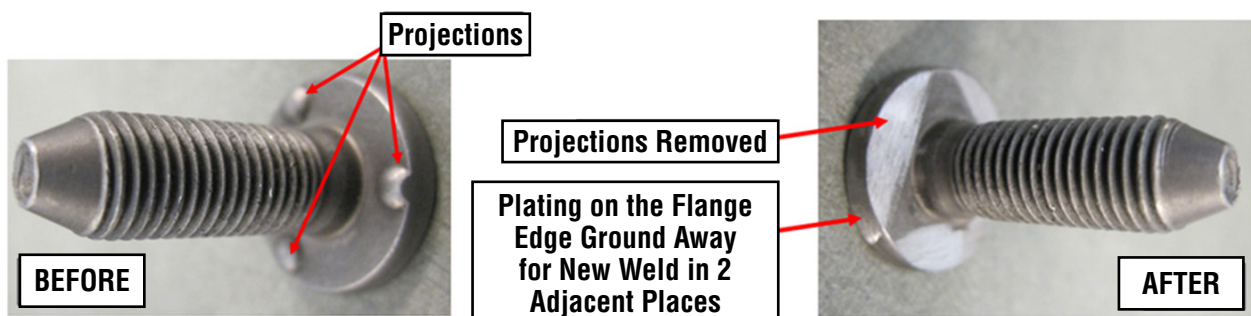
- Before the new stud bolt(s) can be installed, the three projections on the underside of the flange shown in the “before” photo below must be removed as it **MUST SIT FLUSH** against the sheet metal before it can be welded to the vehicle. In addition, lightly grind the plating off of 2 adjacent spots on the edge of the flange where the new welds will be applied. Always take precautions to protect the threads when grinding off the projections. A stud ready to install and weld is shown in the “after” photo below.

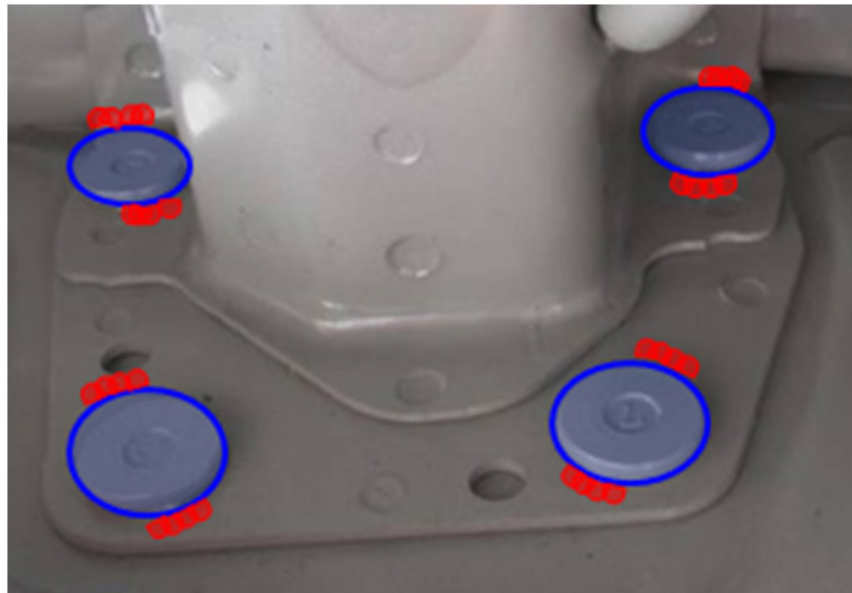
- After securing the new stud bolts to the body panel, apply 2 welds approximately ¼” long and adjacent to each other to secure each stud bolt in place as shown in RED in the reference illustration below.

- When welding is complete, restore the vehicle’s corrosion protection, sound deadening and undercoating to OEM specifications.

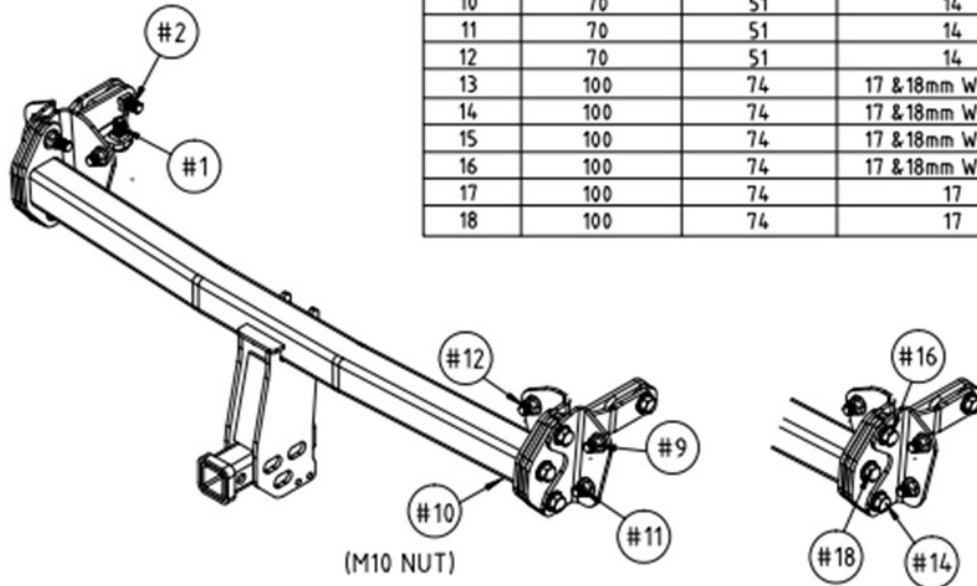
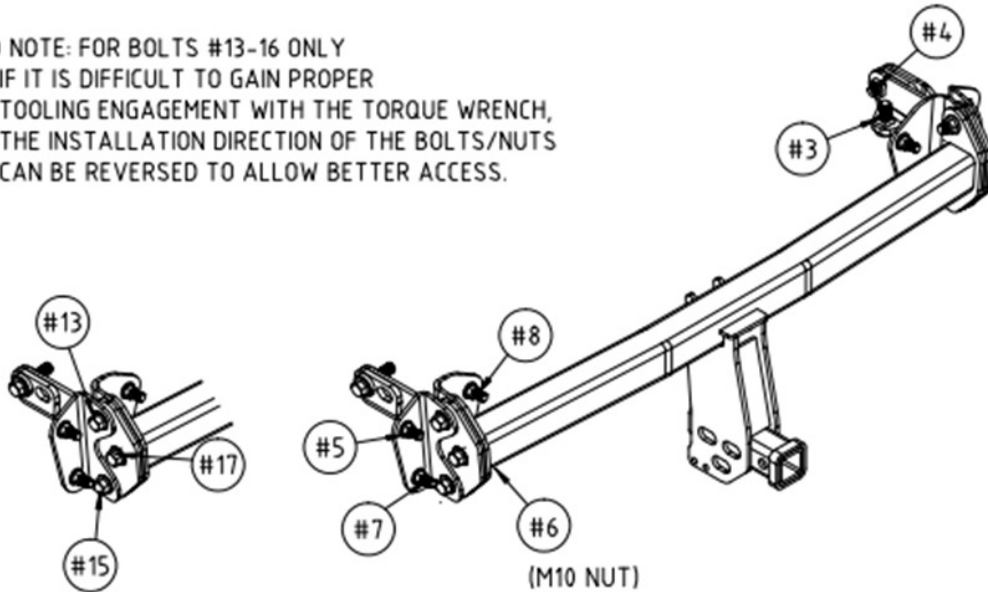
## TORQUE FASTENERS

**VERY IMPORTANT:** Follow the torque values and tightening sequence of all the fasteners closely per the following table:

2) NOTE: FOR BOLTS #13-16 ONLY IF IT IS DIFFICULT TO GAIN PROPER TOOLING ENGAGEMENT WITH THE TORQUE WRENCH, THE INSTALLATION DIRECTION OF THE BOLTS/NUTS CAN BE REVERSED TO ALLOW BETTER ACCESS.
