## SERVICE BULLETIN

**APPLICABILITY:** 2013MY Legacy and Outback Models with 2.5L FB Engines  
 2011-14MY Forester Models with 2.5L FB Engines  
 2012-13MY Impreza and 2013MY XV Crosstrek Models with 2.0L FB Engine

**NUMBER:** 02-157-14R  
**DATE:** 08/28/14  
**REVISED:** 09/29/14

**SUBJECT:** Surface Treatment Change To Oil Control Piston Rings

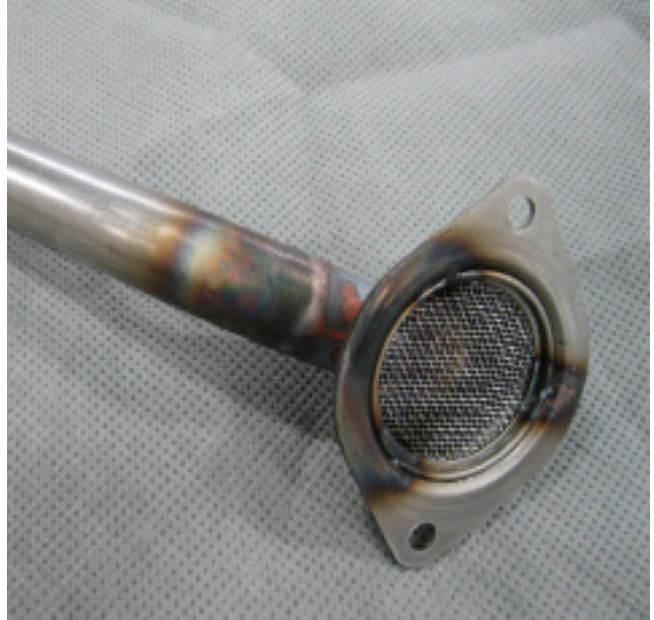
Oil Pick Up Tube/Filter Screen Assembly

- Before installing the upper and lower oil pans, **always thoroughly clean and inspect the pick-up tube and screen.** Always use new o-rings on the pick-up tube and both oil pans during reassembly.
- Once the basic “long block” has been reassembled (valve cover to valve cover), proceed with installation of the timing components as outlined below.
