SERVICE BULLETIN

APPLICABILITY: 2014MY XV Crosstrek Hybrid (HEV) Models with Fujitsu-Ten (F10) SD Navigation / Audio System **NUMBER:** 15-176-14
SUBJECT: Audio Volume Level Drops While Driving **DATE:** 10/15/14

INTRODUCTION

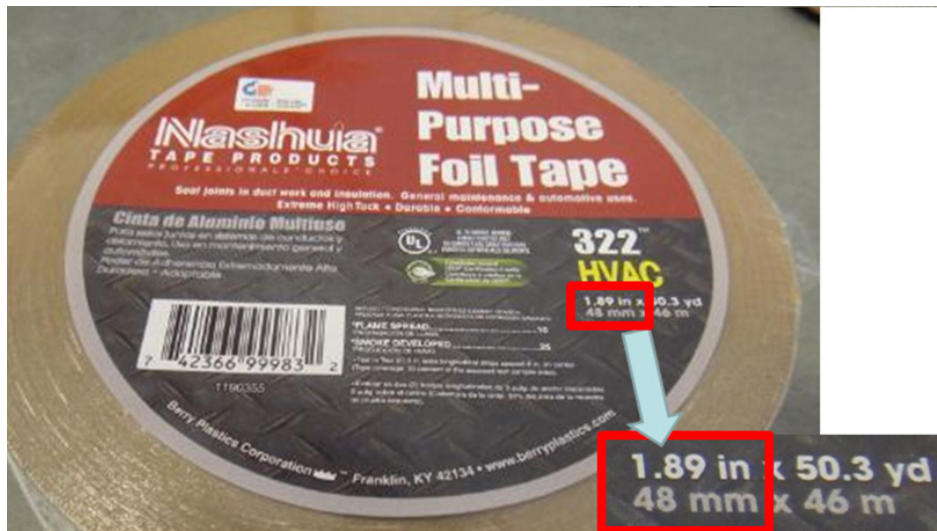
This service procedure involves application of self-adhesive foil tape to “seal” the gaps between the stamped aluminum battery cover and the vehicle body in the areas shown in the photos below.
