SERVICE BULLETIN

APPLICABILITY: 2014-15MY Forester 2.5L NA Models **NUMBER:** 11-148-14R
SUBJECT: Reprogramming File Availability for Oil Level Detection **DATE:** 10/28/14
REVISED: 12/01/14

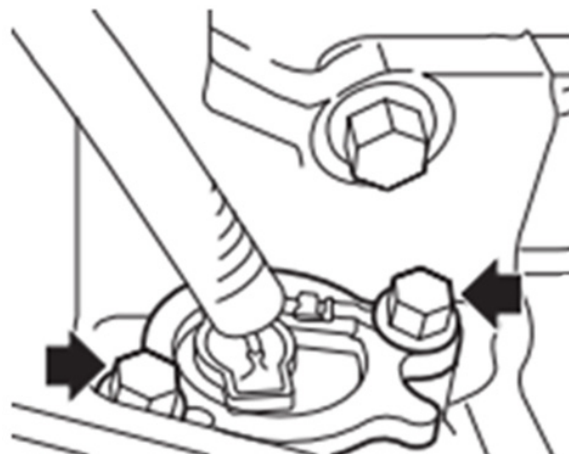
This bulletin announces the availability of reprogramming files and a revised oil level switch to optimize the ECM logic for engine oil level detection in the event of false or premature low engine oil level warning lamp illumination. Should a customer present a concern with a low engine oil warning lamp illumination and the diagnosis indicate the oil level is full or nearly full (oil level between the full and add marks/holes on the dipstick) and the customer has not added any engine oil, the ECM must be updated with this new logic and the oil level switch replaced. The new oil level switch part number supplied in this bulletin must be used. If the customer has added oil, determine how much was added. Based upon the information provided, estimate where the oil level was when the lamp illuminated in order to determine if additional action is required beyond what is described in this bulletin such as an oil consumption test. The ECM must still be updated with this new logic and the oil level switch replaced. The new oil level switch part number supplied in this bulletin must be used.

Step 3 - Once the ECM reprogramming has been completed and the oil level switch wiring has been confirmed to be OK, proceed with replacing the oil level switch assembly shown in the illustration below following the procedure outlined in the applicable Service Manual. Torque the 2 retaining bolts to 6.4 Nm (56 inch-pounds).
