SERVICE BULLETIN

APPLICABILITY: 2013-14MY Impreza 2.0L NA Models
 2013-14MY XV Crosstrek, Including Hybrid Model (HEV)

NUMBER: 11-149-14R
DATE: 11/06/14
REVISED: 12/01/14

SUBJECT: Reprogramming File Availability for Oil Level Detection

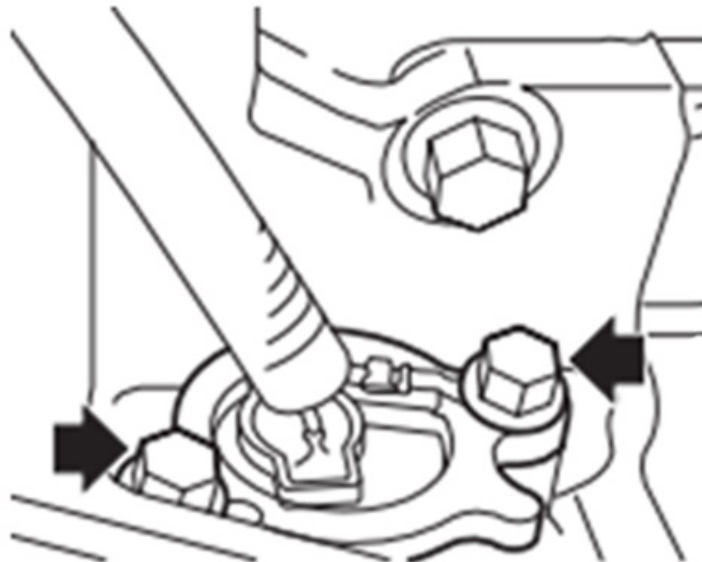
This bulletin announces the availability of reprogramming files and a revised oil level switch to optimize the ECM logic for engine oil level detection in the event of false or premature low engine oil level warning lamp illumination. Should a customer present a concern with a low engine oil warning lamp illumination and the diagnosis indicate the oil level is full or nearly full (oil level between the full and add marks/holes on the dipstick) and the customer has not added any engine oil, the ECM must be updated with this new logic and the oil level switch replaced. The new oil level switch part number supplied in this bulletin must be used. If the customer has added oil, determine how much was added. Based upon the information provided, estimate where the oil level was when the lamp illuminated in order to determine if additional action is required beyond what is described in this bulletin such as an oil consumption test. The ECM must still be updated with this new logic and the oil level switch replaced. The new oil level switch part number supplied in this bulletin must be used.

Step 3 - Once the ECM reprogramming has been completed and the oil level switch wiring has been confirmed to be OK, proceed with replacing the oil level switch assembly shown in the illustration below following the procedure outlined in the applicable Service Manual. Torque the 2 retaining bolts to 6.4 Nm (56 inch-pounds). Torque the 2 retaining bolts to 6.4 Nm (56 inch-pounds).
