## **Tech Tips**

TT 24-08-01 Date: 2008

1998-2005 Models with 1.8T Engine - Pressure Loss Fault Code P1297

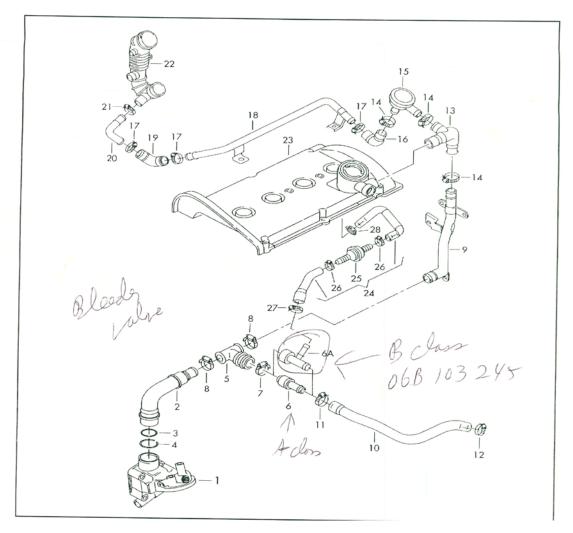
Fault code P1297 may be set and fuel mixtures may go lean if the vehicle is driven under load or revved up and then returned to idle. If these symptoms should occur, it is recommended to check the pressure relief valve in the crankcase breather system (as shown below) to ensure the valve is moving freely. Replace as necessary.
