# Service Bulletin

Bulletin No.: PI0235H

**Subject:** Exhaust Leak or Vibration/Rattle Noise at Approximately 900 RPM, Fuel Smell, White Smoke, Oily Substance on Exhaust Downpipe

**Models:** 2011-2015 Chevrolet Express 2500/3500/4500, Silverado 2500HD/3500HD  
2011-2015 GMC Savana 2500/3500/4500, Sierra 2500HD/3500HD  
Equipped with 6.6L Duramax® Diesel Engine (RPOs LML or LGH)

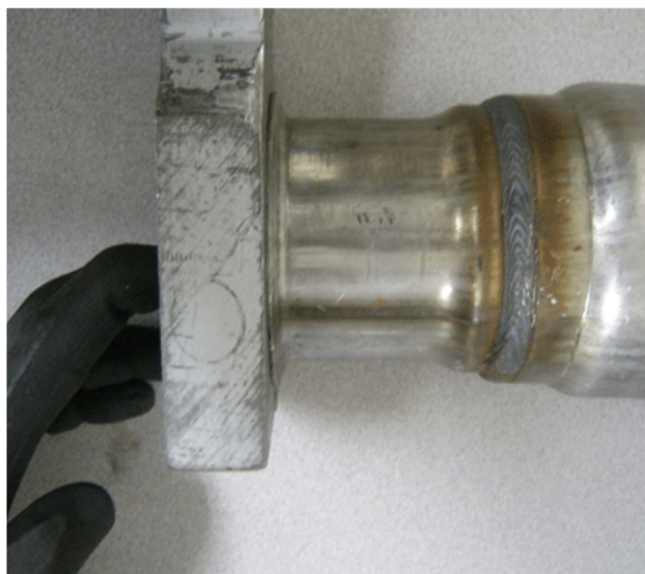
2748856

**In most cases it will not be necessary to replace the exhaust downpipe/catalytic converter assembly for this condition.** However if the mating flange on the exhaust downpipe/catalytic converter assembly is not true, it is possible a leak may occur.

This can be inspected easily by placing a gauge block flush against the flange and inspect for excessive gaps or damage to the flange.

If there are gaps, the converter may need replacing, but the new gasket should compensate for minor surface variation. It is preferred that the alignment process is attempted prior to replacing the converter. There have been very few cases that required the converter to correct this condition.
