Service Bulletin

Bulletin No.: PI0240C

Subject: Front Fascia Lower Air Dam Exhibits Poor Fit and/or Appears Mismatched, Wavy or Gapped to Fascia

Models: 2010-2015 Cadillac SRX

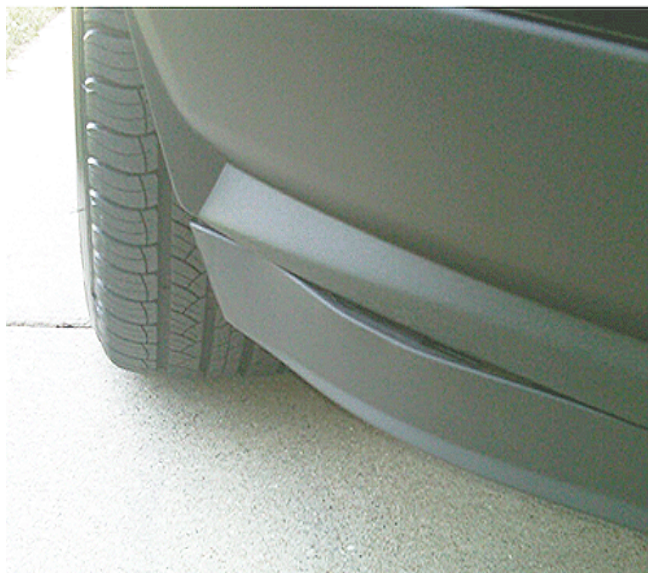
Passenger Side Air Dam

Some customers may comment that the front fascia lower air dam fits poorly to the fascia. The common descriptions are that the dam appears mismatched, wavy or gapped to the fascia. Some examples are shown in the graphics below.

The concerns may be caused by improper installation of the front fascia lower air dam during PDI. The two previous examples showed incorrectly installed second location attachments on each side of the air dam. A close-up graphic of the driver side (shown below) indicates that in both second attachment locations, the air dam tongue (1) was not properly installed into the channel on the fascia.

In order to obtain the proper fit, it is important to follow the Installation instructions included in each front lower air dam kit. No additional parts are necessary as all components are included in the kit.
