Service Bulletin

Bulletin No.: PI0659C

Subject: Groan, Squeak or Rubbing Type Noise When Turning Steering Wheel

Models: 2010-2014 Buick LaCrosse
2012-2014 Buick Regal
2014 Chevrolet Impala
2013-2014 Chevrolet Malibu

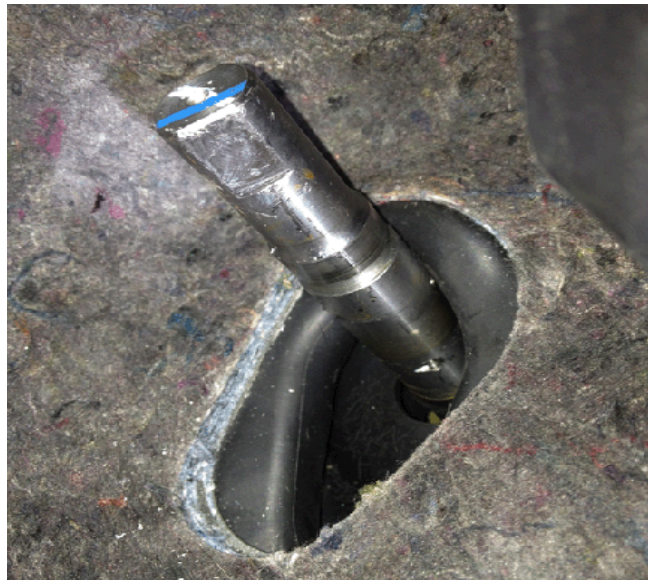
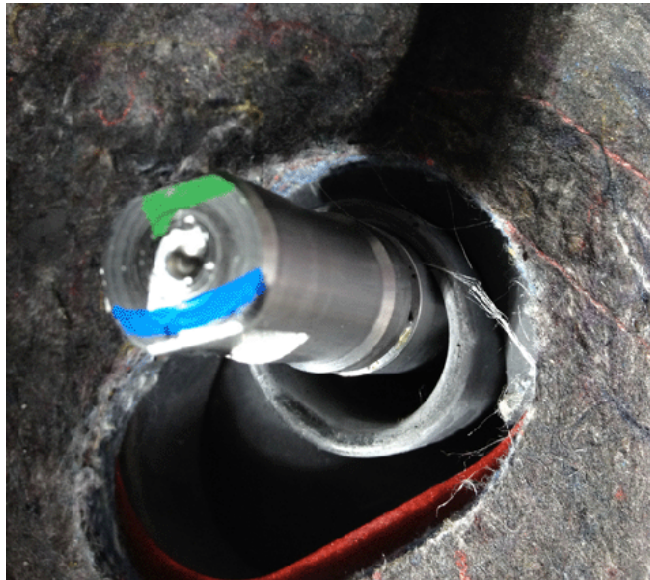
Some customers may comment on a rubber squeak type noise when turning the steering wheel. This condition may be caused by the seal for the intermediate shaft, located at the front of dash, rubbing on the rotating intermediate steering shaft. Refer to the pictures above. On electronic power steering (EPS) equipped vehicles, the EPS wire harness bracket may be contacting the steering column seal.

Technicians should inspect the steering column seal for proper installation by repositioning the inner intermediate steering shaft boot assembly to gain access. Inspect the seal at the front of the dash where the intermediate steering shaft passes through from the steering gear. Ensure that the seal is centered in the opening and around the intermediate steering shaft as shown above. If the seal is out of position, replace the steering column seal following the steps below.
