# Service Bulletin

Bulletin No.: PIP4554K

**Subject:** Clunk Noise After Shifting From Reverse To Drive Or Drive To Reverse And Then Accelerating

**Models:** 2007-2009 Cadillac SRX  
2007-2011 Cadillac STS  
2008-2013 Cadillac CTS  
2010-2014 Chevrolet Camaro  
RWD only, equipped with 6L45 or 6L50 (RPO MYA, MYB) Automatic Transmission

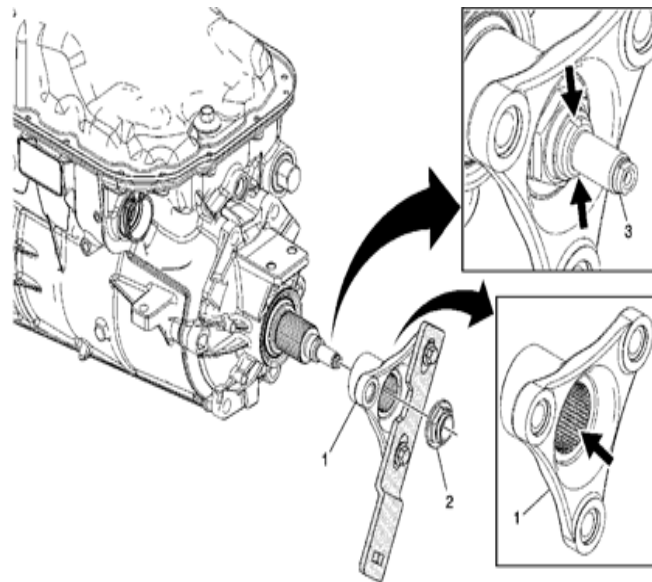
2610907

Some customers may comment on a clunk noise after shifting from Reverse to Drive or Drive to Reverse and then accelerating, this noise typically does not occur during the reverse to drive or drive to reverse shift, but is heard after the shift when the vehicle is accelerated. The noise may sound like it is coming from the rear of the vehicle from the rear drive axle.

This condition may be caused by the torque on the propeller shaft flange nut or movement between the flange and the transmission output shaft.

Apply thread locker to the transmission output shaft flange splines and a new front propeller shaft flange nut following the procedure below.

The existing output shaft and output shaft flange can be re-used and does not require replacement. A new front propeller shaft flange nut should be used.

### Callout 1

Component Name: Propeller Shaft Transmission Flange

1. The output shaft flange splines must be thoroughly clean and dry before installing the flange.

2. Apply GM P/N 89021297 (Canadian P/N 10953488) evenly across the width and length of the flange splines and install the flange onto the transmission output shaft.
3. Sufficient application of adhesive to every tooth on the flange will leave excess adhesive on the output shaft after installation. If no excess is observed, reapply adhesive. Remove excess adhesive.

### Callout 2

Component Name: NEW Front Propeller Shaft Flange Nut

1. The output shaft nut threads must be thoroughly clean and dry before installing the nut.
2. Apply GM P/N 89021297 (Canadian P/N 10953488) across the width of the nut threads, prior to tightening and staking.

Tighten 55 N·m (41 lb ft).

### Callout 3

Component Name: Output Shaft

**Caution:** Stake the flange nut onto the output shaft. Use the two staking grooves on the shaft to locate the staking points. Failure to stake the flange nut may result in damage to the transmission.
