UPDATE Technical Bulletin

UPDATE – 97AO Fuse Box Washers (NVLW)

Model(s)	Year	Engine Code	Trans. Code
Passat	2013-2014	All	All

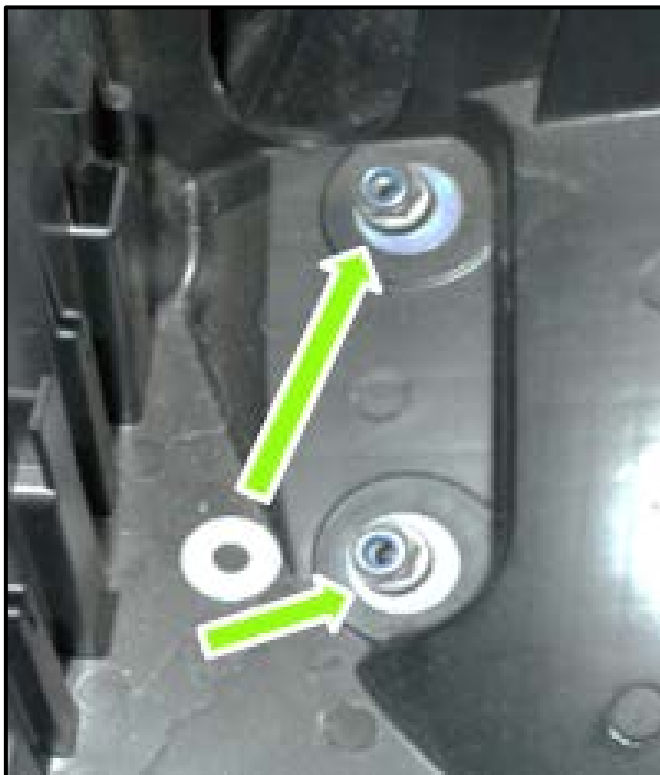
As a result of the fuse box weld pin length used during production, the fuse box wiring harness could come in contact with the fuse box weld pins.

⇐ Place 1 washer part number (N 011 666 20) onto each mounting stud, then reinstall the nut onto the mounting stud.

- Torque each nut to 6Nm.

Note: It is not necessary to remove the existing washers from the mounting studs. Simply install the replacement washers over top, then reinstall each nut.
