# Service Bulletin

## CUSTOMER SATISFACTION PROGRAM

**Subject:** 09132E – Power Steering Hose Leak (Program Expired)

**Models:** 2006 Chevrolet Impala, Monte Carlo (V6 & V8 Engine)  
2005-2006 Pontiac Grand Prix (V8 Engine)

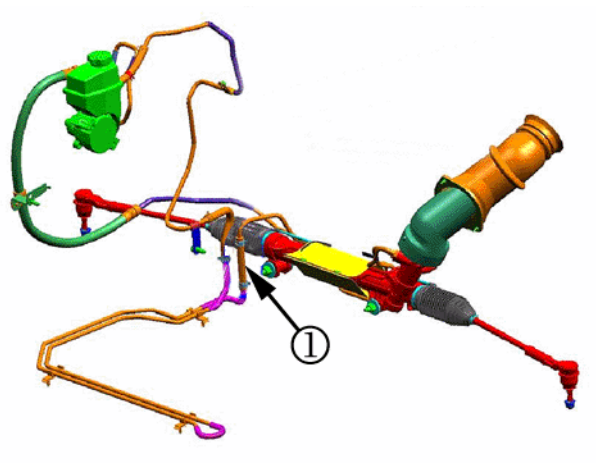
**Certain** 2006 model Chevrolet Impala and Monte Carlo vehicles equipped with a V6 or V8 engine, and 2005 and 2006 model year Pontiac Grand Prix vehicles equipped with a V8 engine may have a condition in which the power steering cooler line may leak or split. When these vehicles are started in cold weather, the pressure on the hose is substantially higher than in warmer weather and may exceed the strength of the power steering hose or clamps. If this were to occur, the driver would likely notice fluid spotting under the vehicle when the vehicle is parked and a decrease in the power steering assist. If enough fluid were lost, damage to the power steering pump could occur.

**Note:** The location of the leak (1) is shown above. The power steering cooler hose may leak from the hose clamp.

Dealers are to replace the power steering hose assembly on vehicles with a V8 engine, or replace a length of hose and clamps on vehicles with a V6 engine.

1. Raise and support the vehicle. Refer to the Lifting and Jacking the Vehicle procedure in SI.
2. Place a drain pan under the repair area.
3. Remove the power steering hose clamps.
4. Remove the power steering hose from the vehicle.

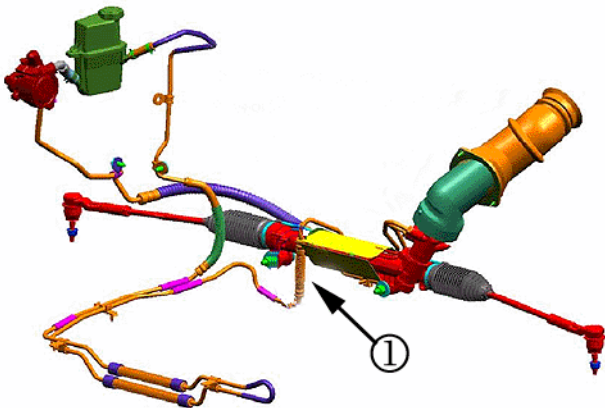
**Note:** The location of the leak (1) is shown above. Fittings on the hose are crimped socket and are not likely to leak.
