Service Bulletin

Bulletin No.: PIP4905C

Subject: Vehicle Will Not Charge DTC P0D26

Models: 2011-2014 Chevrolet Volt
2014 Cadillac ELR

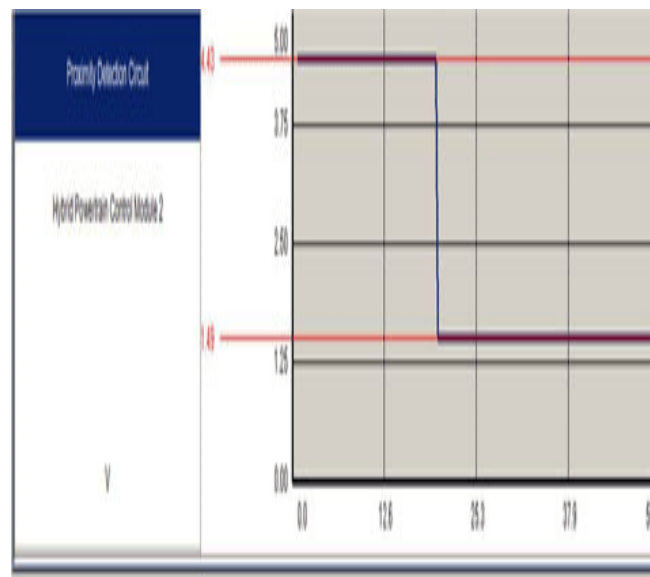
Good Signal

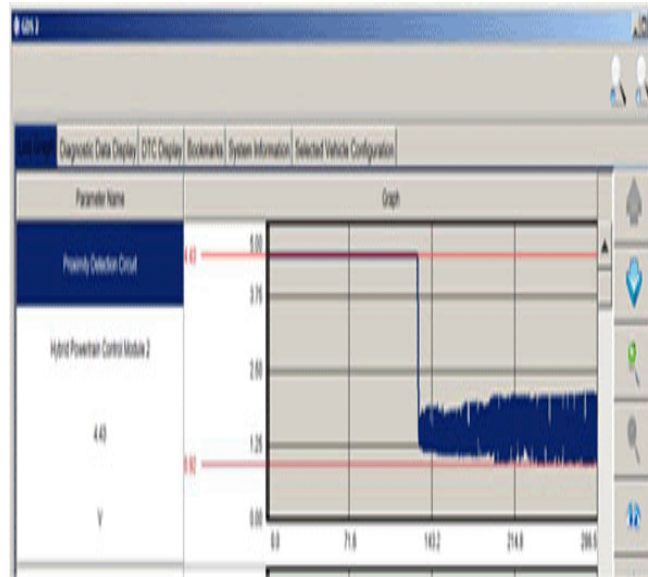
Erratic Signal

6. If your snapshot shows the erratic signal above, and/or the condition changes with charge cord coupler (handle) manipulation, or the proximity signal does not drop to a steady 1.49 volts it will be necessary to inspect the charge port receptacle and wiring.

7. Inspect the charge port receptacle connector for signs of water intrusion or corrosion in both the vehicle harness side and charge port side. If a concern is found it will be necessary to replace the receptacle and repair the harness as needed.
