Service Bulletin

Bulletin No.: PIP5029F

Subject: Rough Idle Crank No Start Extended Crank Or Misfire Due to Excessive Carbon On Top of the Valves or Sticking Valves

Models: 2000-2015 All Passenger Cars with Gasoline Engines
2000-2015 All Light Duty Trucks with Gasoline Engines

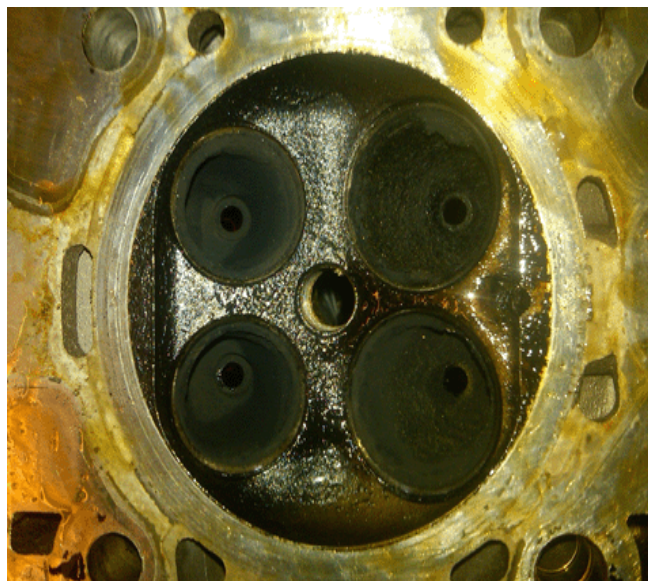
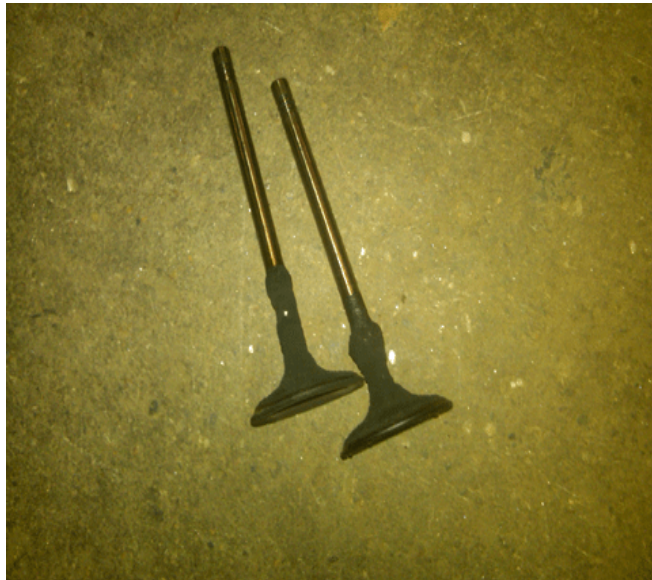
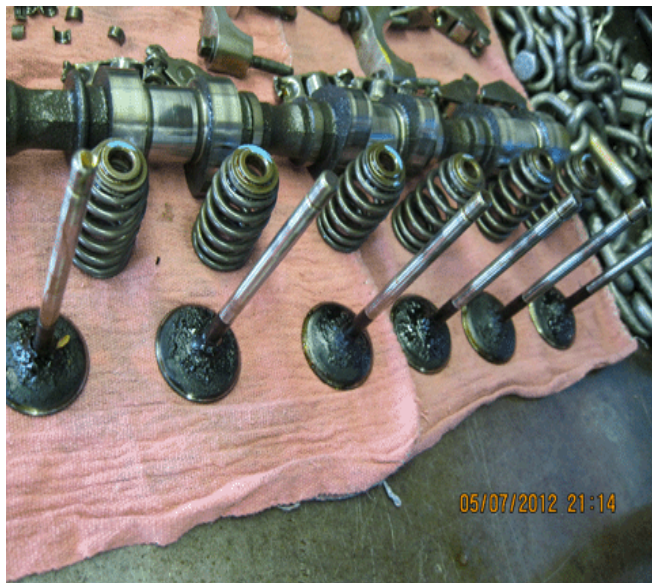
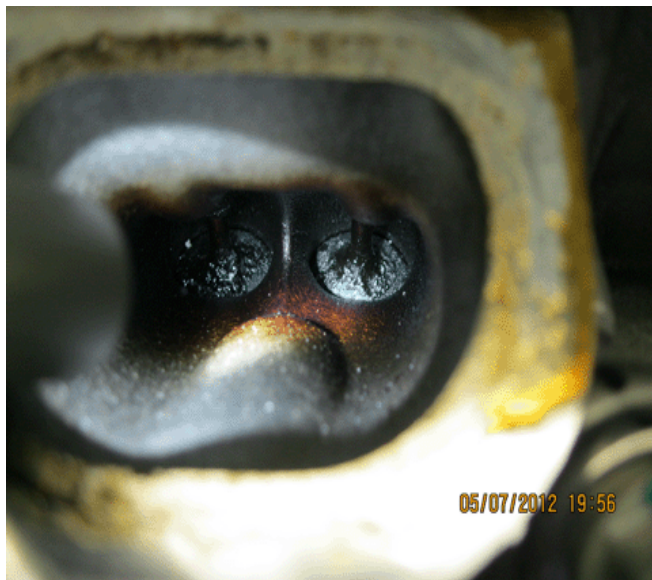
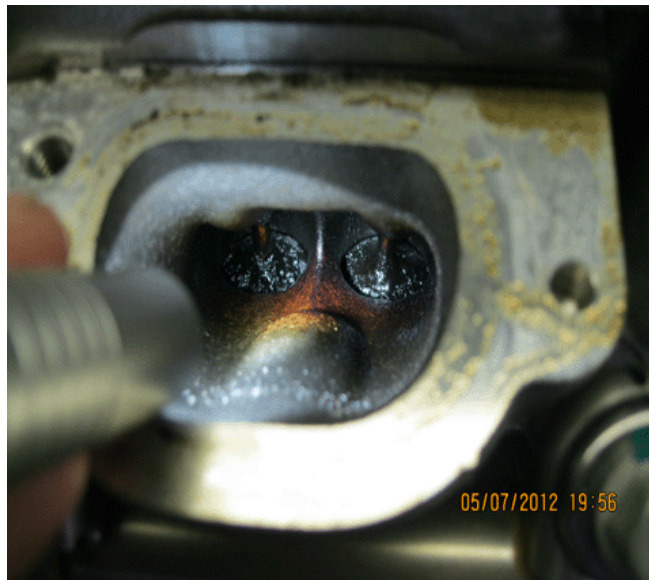
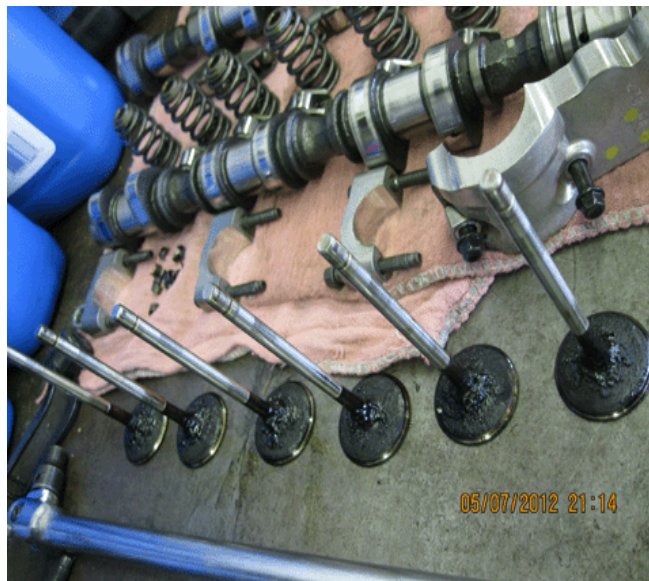
This may be the result of major carbon build up on the intake and/or exhaust valves due to fuel contamination or incomplete burning of the fuel as shown below so the misfires should not have appeared until accumulating at least 5,000 miles or more.

When the engine is cold, the compression on multiple cylinders may be at 0 PSI.

The engine also may pop through the intake or exhaust while cranking and the spark plugs may be fuel fouled when inspected.

Some engines may also experience valve damage or cam followers that are out of position as a result of this.

If there is no sign of valve damage or cam followers that are out of place, perform the following procedure to free up sticking valves and to remove carbon from the valves and pistons.

If valve damage is present or if there are cam followers that are out of place, perform engine mechanical repairs as necessary to correct the concern and then perform the procedure below to prevent the concern from returning.

Perform an upper engine and valve cleaning procedure as outlined below.

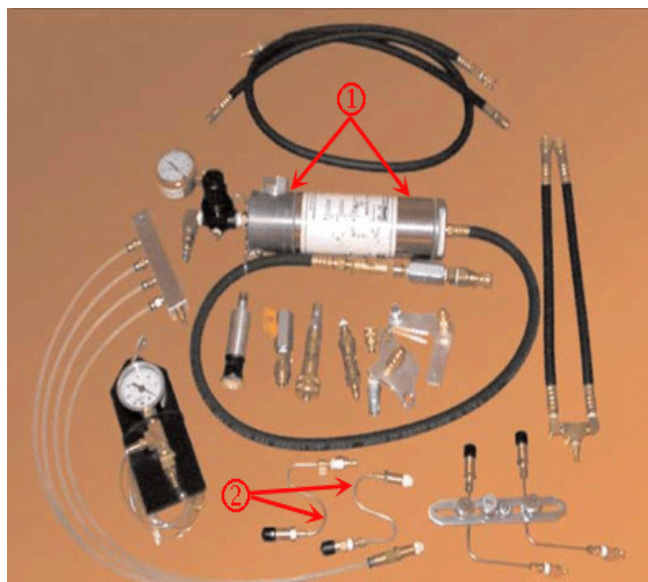
Kent Moore Tool Kit # J-45076

1. Pressurized Canister from J-45076 is Shown - J-35800-A is Similar (Equivalent Pressurized Canister Acceptable)
2. Throttle Body Cleaning Adapters J-45076-46 and J-45076-55 Shown (Equivalent Adapters Acceptable)

1. In a well-ventilated area with the engine at operating temperature, slowly/carefully induce a bottle of GM Upper Engine and Fuel Injection Cleaner into the engine with RPM off of idle enough to prevent the engine from stalling (typically around 2,000 RPM or so). Depending on the engine configuration, induce the cleaner through the throttle body or an engine vacuum hose/pipe. ***For best results, it is suggested to induce the cleaner through the throttle body with Kent Moore Tool # J-45076 / J-35800-A or equivalent (shown below).
