Service Bulletin

Bulletin No.: PIP5156A

Subject: Oil Leak After The Balancer Is Removed Or Replaced

Models: 2015 Cadillac Escalade
2014 Chevrolet Corvette
2014-2015 Chevrolet Silverado 1500 Suburban, Tahoe
2014-2015 GMC Sierra 1500 Yukon Yukon XL

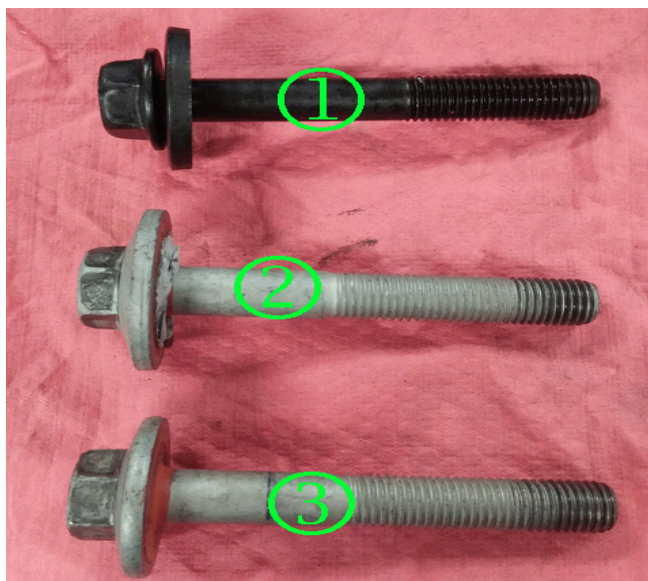
Note: If you use a Gen 4 bolt in a Gen5 engine you will have an oil leak.

1- is for a Gen 5 engine

2- is for a Gen 5 engine

3- is for a Gen 4 engine

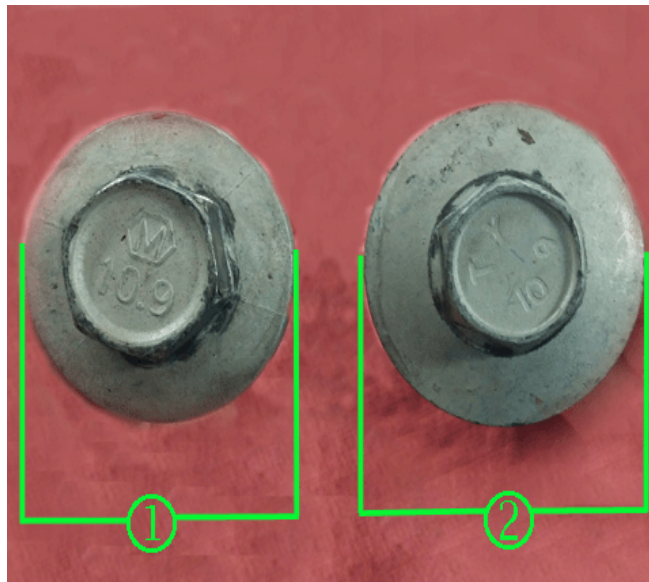
4043629

1- 1 piece Gen 4 bolt measures 1.869 at the flange

2- 1 piece Gen 5 Bolt measures 2.055 at the flange

LT1 dry sump uses a longer bolt due to the oil pump that is used on this system.
