# Service Bulletin

Bulletin No.: PIP5175B

**Subject:** Slip Or Shudder During A Launch In First Second Third Or Fourth Gears Delayed Engagement Into Drive Clunk Or Bump During The 1-2 Shift

**Models:** 2013-2015 Cadillac Escalade  
2013 Chevrolet Avalanche  
2013-2014 Chevrolet Caprice, Silverado  
2014 Chevrolet SS  
2013-2015 Chevrolet Suburban, Tahoe  
2013-2014 GMC Sierra  
2013-2015 GMC Yukon, Yukon XL  
Equipped With 6L80 MYC Automatic Transmission Built in the Silao Mexico Plant 2  
**Note:** Please refer to SI document 2610129. The following information only applies to transmissions with a source code (item number 7 in document 2610129) of (2).

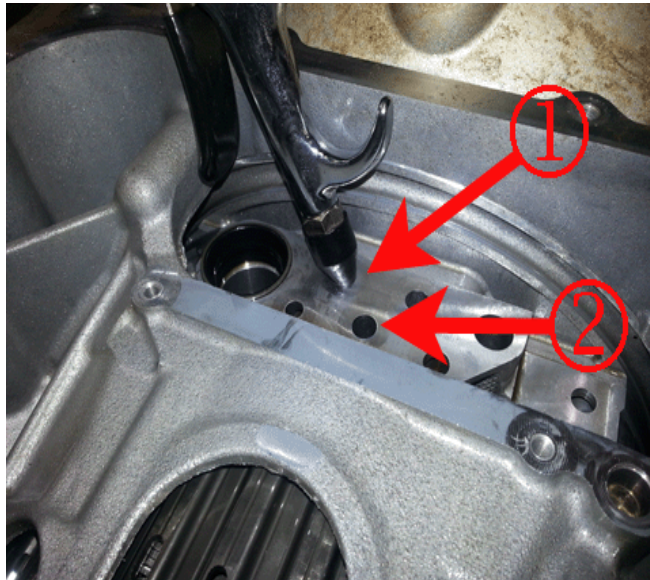
3704964

Referring to the picture below and wearing proper eye protection apply compressed air to the 1-2-3-4 clutch apply passage and inspect for air leaking out of the compensator feed passage in the pump cover.

If no leakage is found out of the compensator feed passage listen for excessive air leakage inside the transmission.

Callout 1

Component Name: Applying compressed air to the 1234 clutch passage.

Callout 2

Component Name: Compensator feed passage.

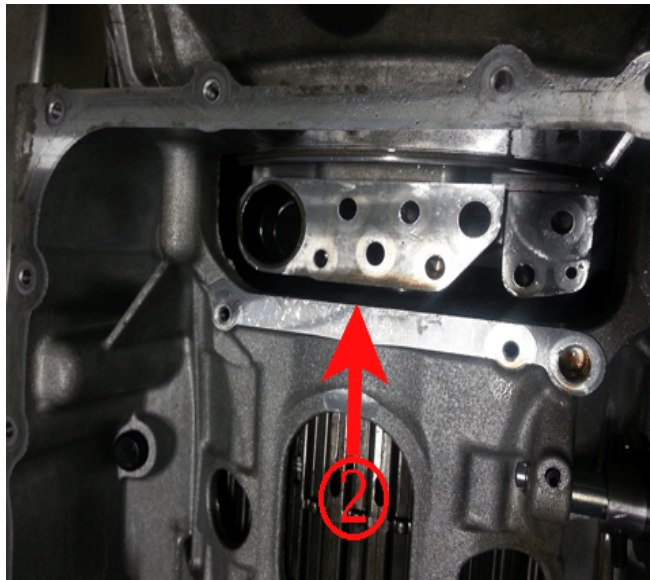
3687439

You may also notice fluid leaking or see a misaligned gasket by looking up through the case opening between the pump stator support and the 1234/35R clutch housing during this test as shown below.

Callout 2

Component Name: Gap between the pump cover and the 1234/35R clutch housing.

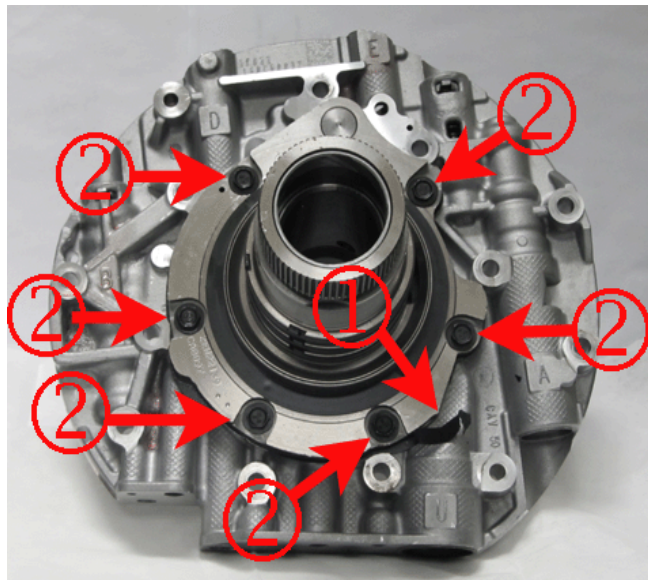
3688815

If excessive air leakage is found inspect the transmission fluid pump for loose stator support to pump cover bolts or a misaligned stator support to pump cover gasket.

Callout 1

Component Name: Misaligned Gasket

Callout 2

Component Name: Stator Support Bolts

If any of the bolts are loose or the gasket is misaligned or leaking, the transmission pump cover must be replaced and the 1234 clutch plates should be inspected for being distressed and repaired as needed.

**Note:** The transmission adapts must be reset if the pump cover is replaced to address this concern.
