Service Bulletin

Bulletin No.: PIP5198

Subject: Instrument Panel Cluster (IPC) Warning Lamps And/Or MIL Are Illuminated Diesel Exhaust Fluid (DEF) Message Displayed Various DTCs Set (Inspect Wiring Harnesses for Chafing)

Models: 2015 Chevrolet Silverado
2015 GMC Sierra
Equipped with 6.6L Duramax™ Diesel Engine RPO LML

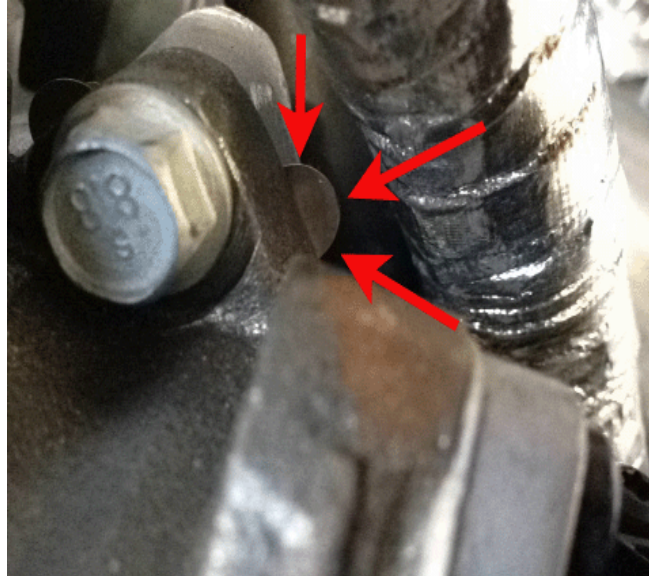
3826299

If the diagnosis does not lead to a resolution or if the symptoms or DTCs are intermittent and cannot be duplicated, check for chafing of the engine wiring harness that is routed near the EGR Valve. The wiring harness has been found chafed on a tab of the EGR Valve metal gasket.

Repair or replace the wiring harness if it is found chafed on the tab of the EGR Valve metal gasket.

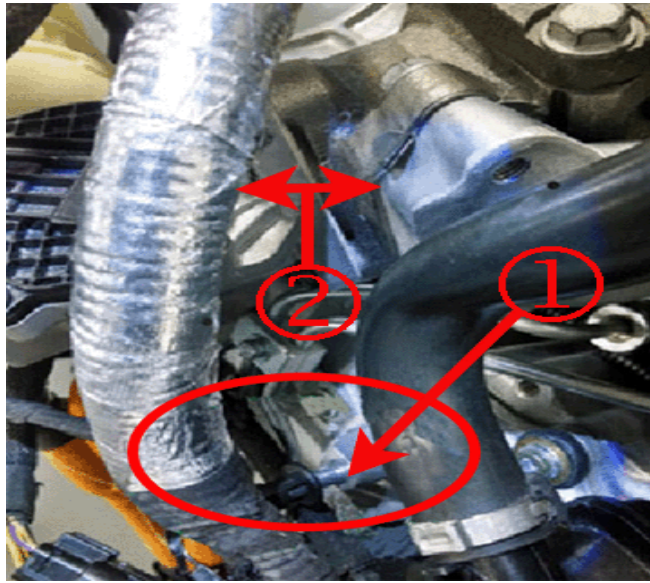
3825841

1. Wiring harness retainer fully seated onto the stud on the driver's side rocker cover.
2. Proper clearance between the harness and the EGR valve

It is critical that the wiring harness retainer is fully seated onto the stud on the driver's side rocker cover. This retainer is tied to the harness and is located underneath the charged air cooler (CAC) inlet pipe near the #4 fuel injector. Proper routing and securing of the harness ensures there is clearance between the harness and the EGR valve.

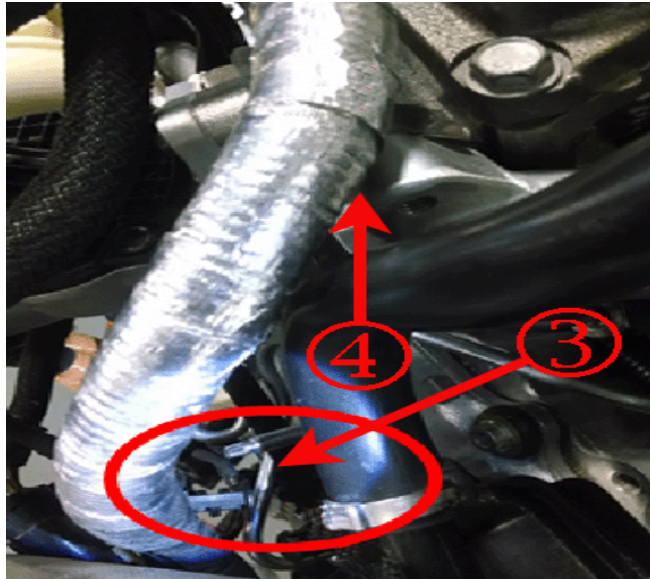
3825844

3. Wiring harness retainer NOT fully seated onto the stud on the driver's side rocker cover.
4. IMPROPER clearance between the harness and the EGR valve.
Bend the tab of the EGR gasket over to prevent a re-occurrence.
