Service Bulletin

Bulletin No.: PI0734A

Subject: Rear Door Glass Lowers without Window Switch Activation, Especially after Car Wash or Rain

Models: 2008-2012 Cadillac CTS Sedan (Including V-Series)
2010-2012 Cadillac CTS Sport Wagon (Including V-Series)
Built Prior to March 14, 2012

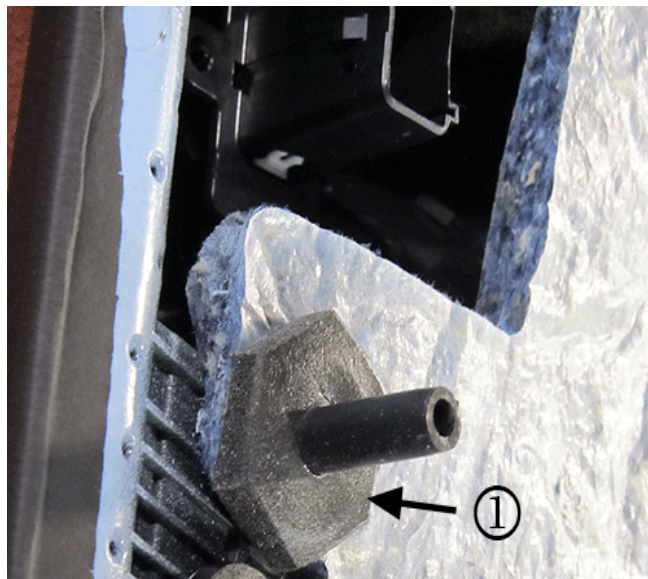
2853944

Note: During trim panel removal, the foam gaskets (1) on the locating pins of the door trim panel have a tendency to temporarily stick to the door sheet metal, then fall off. Make sure to retain these two foam gaskets and reinstall them as instructed in step 7 below.

1. Remove the rear door trim panel on the affected door. Refer to Rear Side Door Trim Panel Replacement (Sedan, Wagon) in SI.
