Service Bulletin

Bulletin No.: PI0776B

Subject: Left Front Fender Liner Rattle, Ticking or Flutter Noise While Driving

Models: 2012-2013 Chevrolet Impala
2014 Chevrolet Impala Limited (VIN W)

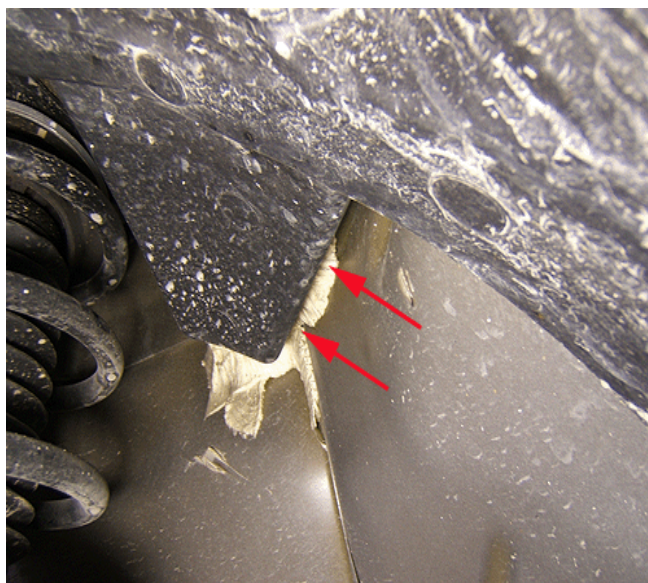
2891248

Some customers may comment on a noise coming from the left front of the vehicle while driving at speeds above 65 km/h (40 mph). This condition may be described as a rattle, flutter or ticking type noise.

This noise may be caused by the left front plastic fender liner (splash shield) making contact with the body structure.
